# A large mid- Saxon timber structure in the intertidal zone Sea View, Mersea Island, Essex Coastal and Intertidal Zone Archaeological Network Report September 2022

Mersea Island
Discovery Programme
CITIZAN

# A large mid- Saxon timber structure in the intertidal zone Sea View, Mersea Island, Essex, TM 02631 12256 Coastal and Intertidal Zone Archaeological Network (CITiZAN) Report

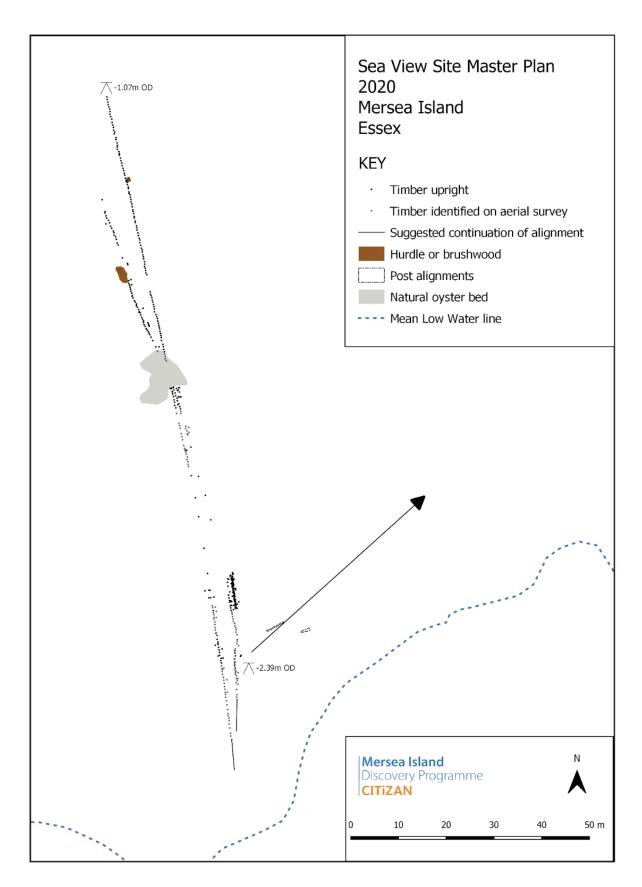
The principle remains observed fall into three categories as identified on the site plan (*fig. 3*) and are grouped thus; 1) two linear timber features, 2) two sections of exposed wattle or brushwood 3) two short alignments of posts running perpendicular to groups 1 and 2.

Figure 3: Plan of Sea View site 2020

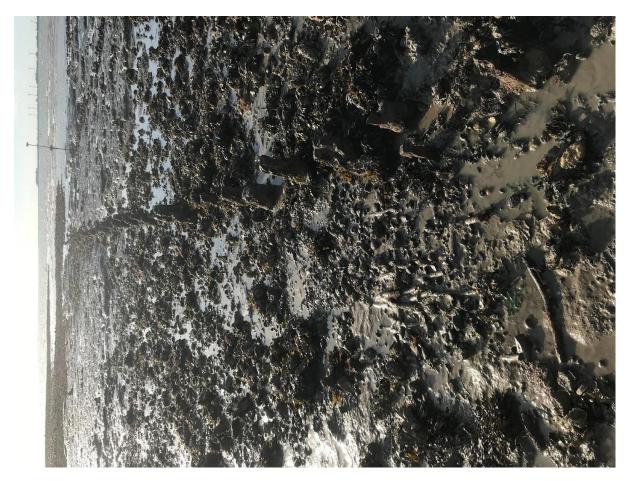
Feature 1: A row of timber piles (fig. 4) running 138m north-south, perpendicular to the present shoreline. The alignment tapers westwards at the southern end towards an adjacent alignment (Feature 2). A natural oyster bed obscures a 5m section roughly in the centre of the row, but it is assumed that Feature 1 is a continuous row given the similarity in timber, spacing and alignment both to the north and south of the oyster bed. A clear terminal was observed at the northern end of the feature, but the observable remains run into the sea to the south making the original extent impossible to identify with certainty. Aerial survey indicates that the row continues beneath the surface of the water for at least a further c.10m on a downward slope into the sea before becoming unobservable beneath the water.

Feature 1 comprised 100 vertical upright timber piles in the round. The piles average 160mm in diameter when measured at the base where the presence of bark indicates their original size as trunks. Over half the timbers have bark present at the base which appears to be a function of recent erosion, and, based on the quality of preservation, indicates that the trunks are likely of birch (Betula). The average diameter suggests the feature is made up of the trunks of relatively young trees, c.20 years old. They stand between 20mm - 600mm proud of the foreshore with the more exposed (and therefore taller) piles found towards the northern section of the alignment. The above ground tips of the piles are heavily eroded, often to a point made up of just heartwood. Below the tip the wood is friable and honeycombed, a likely result of erosion. The piles are regularly spaced averaging 500mm apart and set vertically with a considerable degree of precision. The northernmost exposed pile is squared at the base, measures 100mm diameter across its rounded upper portion and displays extensive tool marks and facets suggesting a worked, pointed end below the surface. To the southern end of the alignment several slightly outlaying piles were recorded, possible repairs or bracing elements. Two small archaeological interventions suggest that the piles were set in a trench backfilled with soft, blue grey, sterile clay although further intervention is required to confirm this proposal. Not all the timber piles in this feature were fully surveyed due to time constraints.

Figure 4: Feature 1 looking south with Feature 3 (hurdle panel) in the foreground. The natural oyster bed that obscures the centre of the alignment can be seen towards the upper portion of the image.

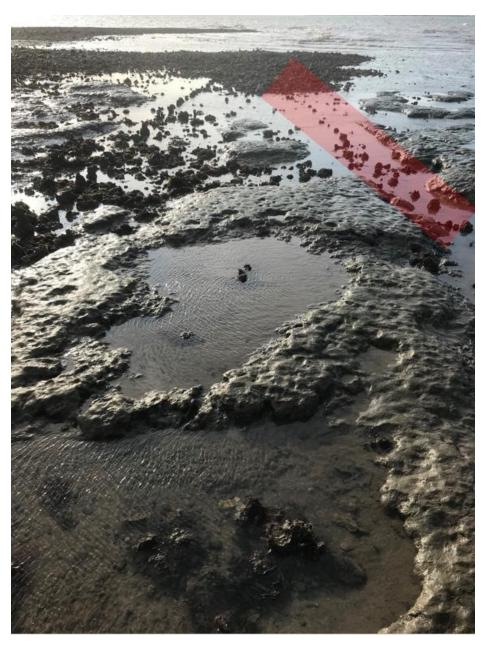
Feature 2: A second row of smaller piles (fig 5.) and stakes extending 124m nw-se. All but one are in the round and they average 100mm diameter. No bark was present on any timbers in this row. All appear to have been set vertically but with less precision than those in Feature 1. Several posts have adjacent smaller stakes (observed but not surveyed due to time constraints) driven in immediately adjacent, presumably wedges or repair work to provide stability. To the immediate south of the oyster bed in the middle of the feature a series of smaller adjacent rows of stakes and posts have been exposed to the east of the main alignment. These range in diameter from 100 – 50mm and are set with their upper tips leaning away (eastwards) from the vertical piles. This form is also evident at the southern end where three further parallel rows of over 40 posts and stakes of various sizes are exposed running for 7m along the eastern (outer) side of the alignment (Fig. X). Set at a variety of

Figure 5: Feature 2 highlighted in red. Image looking south

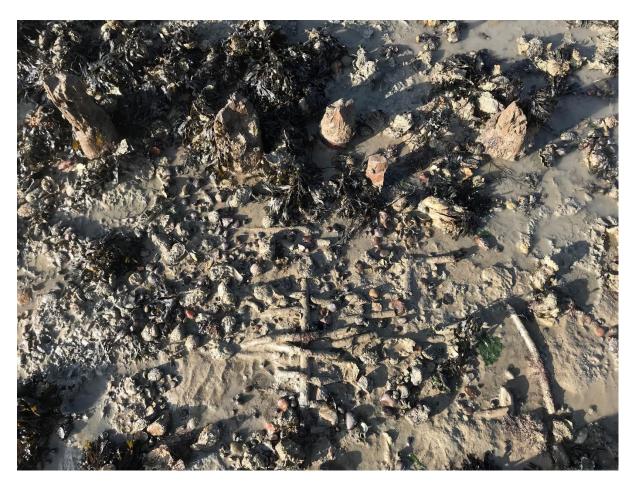
Feature 3: An exposed section of wattle panel (fig 6.) abutting the outer (eastern) face of Feature 1 was identified, cleaned and photographed. It is of rod and sail construction and measures 600 x 700mm. The presumably hazel wattles are firmly embedded in the exposed surface which lies at -1.45m OD. The ends of two wattles show evidence of tool marks. It was not possible to ascertain with certainty if the panel was intentionally laid directly on to the surface beneath or if it came to rest as a result of collapsing from a position affixed to Feature 1. Further monitoring of the feature may provide evidence to establish an answer. Given the risk of loss to erosion this feature was sampled for species ID and C14 dating including two samples on which tool marks are present.

Figure 6: Feature 3 - a section of wattle hurdle work
