Brownsea Island coastal archaeology Poole Harbour Dorset

NGR: SZ 01984 87989 CITiZAN region: South West

Report on a CITiZAN site survey

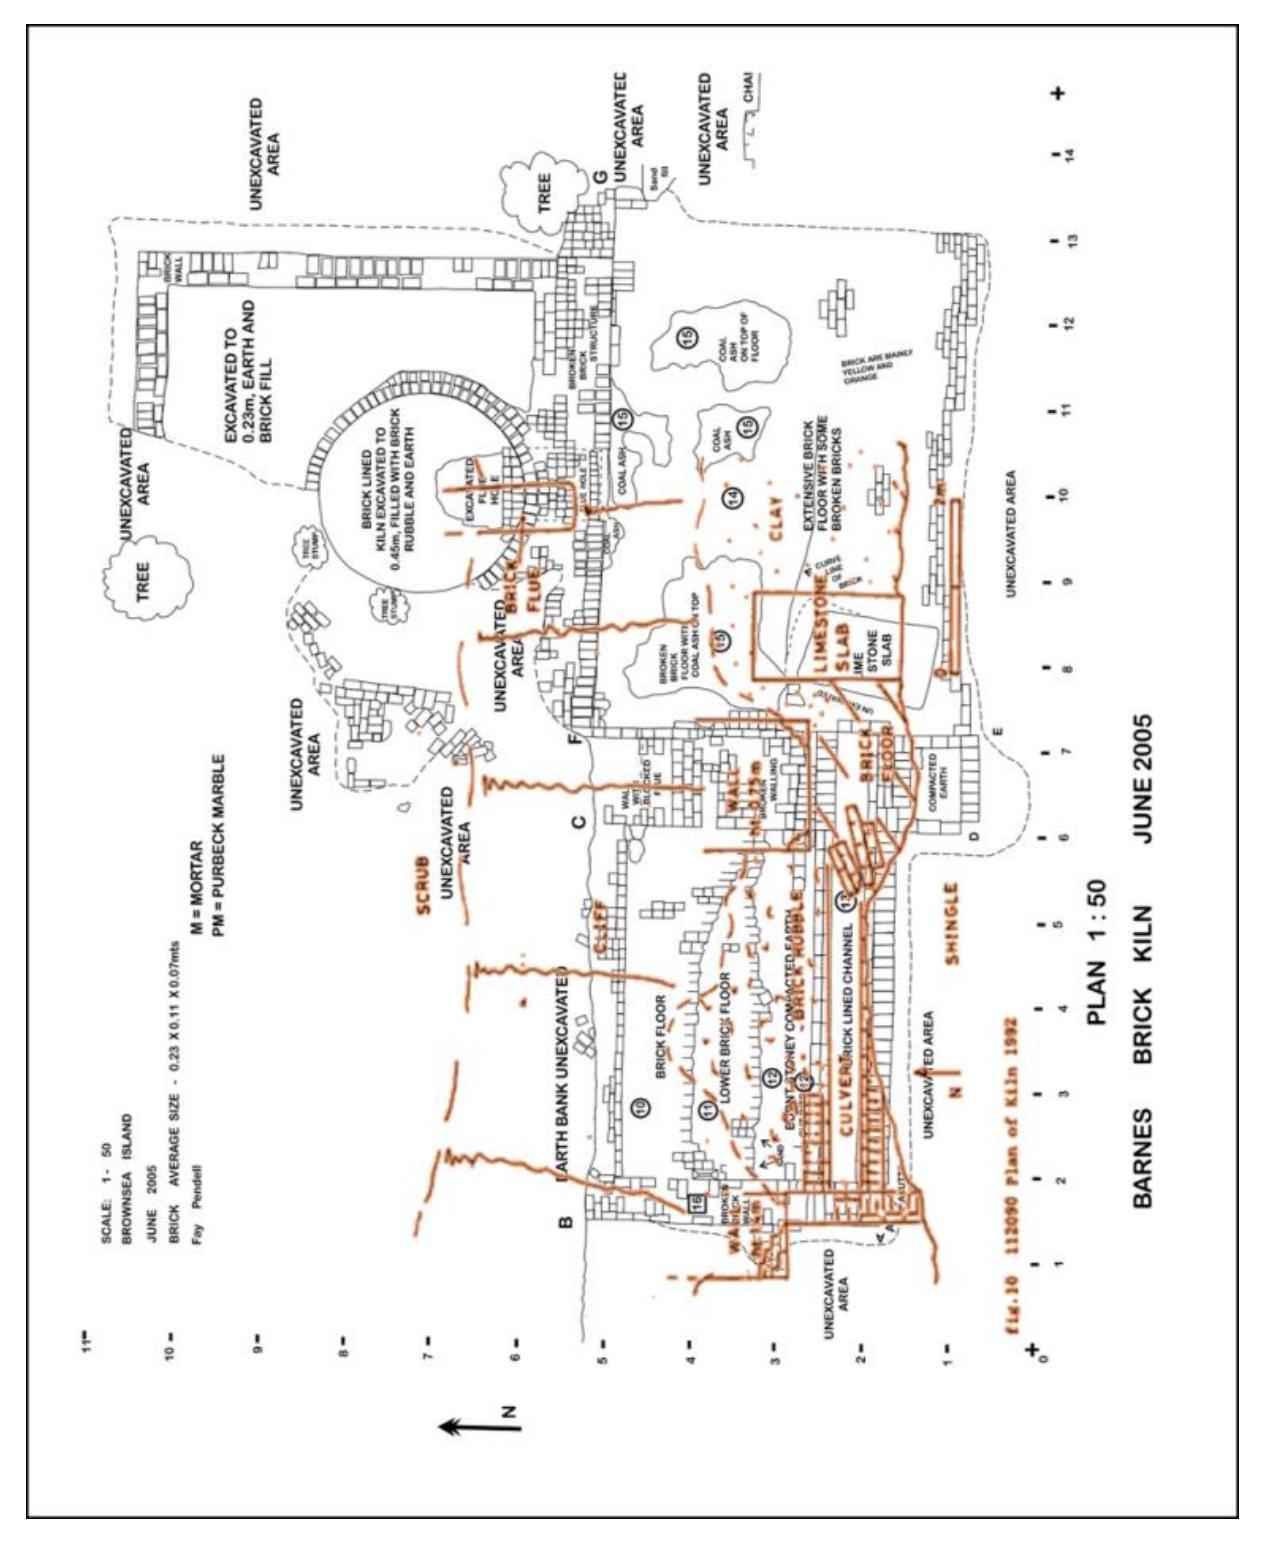
Initial comparisons between the 1992 and 2005 plans can be seen in Figure 21. In 1992 the earth bank was several meters further seawards and only elements of the two southerly rooms were exposed. By 2005 the earth bank had eroded by up to five metres exposing the firing chamber. Comparing the 2005 site plan to the 2015 model shows that by 2015 the southerly rooms have been completely destroyed (Figure 22). All that remained was the north-east room which contained the brick lined kiln. The whole area to the west of this room was covered in an earth bank in 2005. This had eroded by at least 4m so any remains which were covered by that bank have since been lost. Timber posts in the intertidal zone were still visible which were probably the remains of the jetty. By 2016 the brick lined kiln in the north-east room had partially collapsed (Error! Reference source not found.); this may be due to the vegetation growth above the structure as opposed to damage from the sea.

Figure 21: 2005 site plan of Barnes Brick Kiln overlaid with 1992 site plan (Red). Both plans created by the National Trust. This figure shows how far the cliff has eroded back exposing more of the structure.

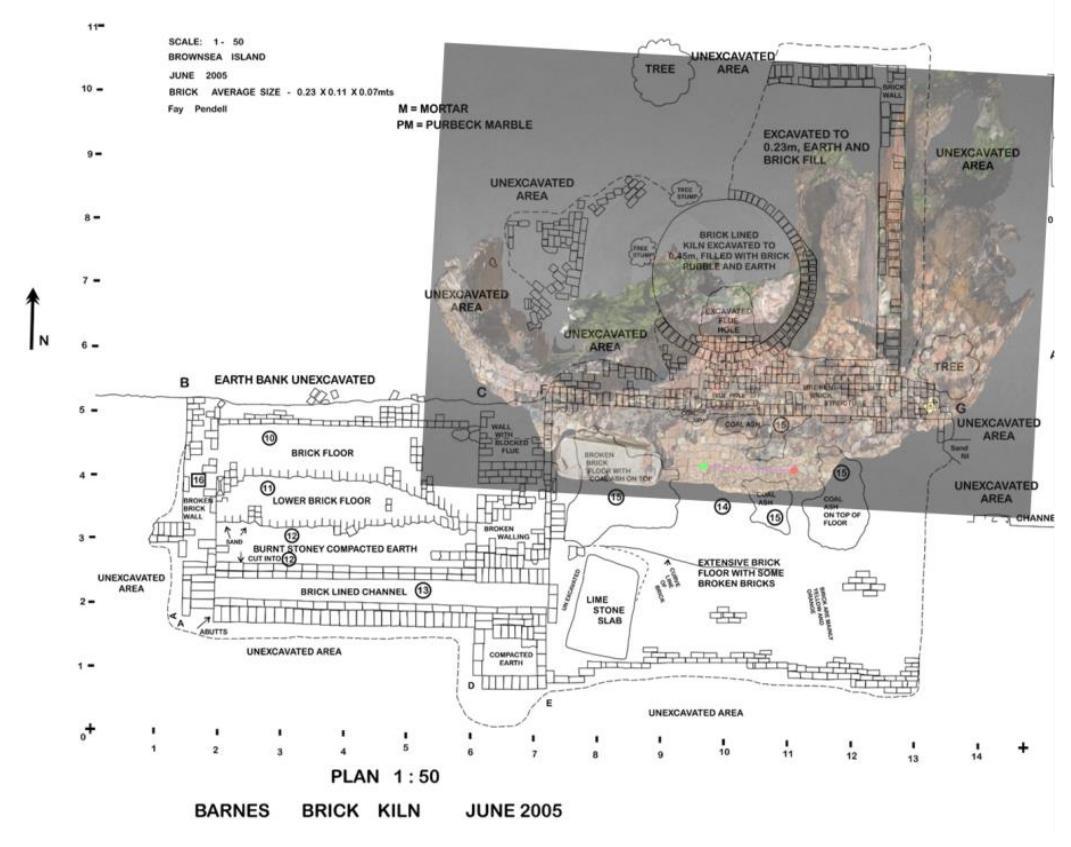
Figure 22: 2005 site plan of Barnes Brick Kiln overlaid with plan view of the 2015 3D model, the two southerly rooms have been destroyed, all that remains is the firing chamber.

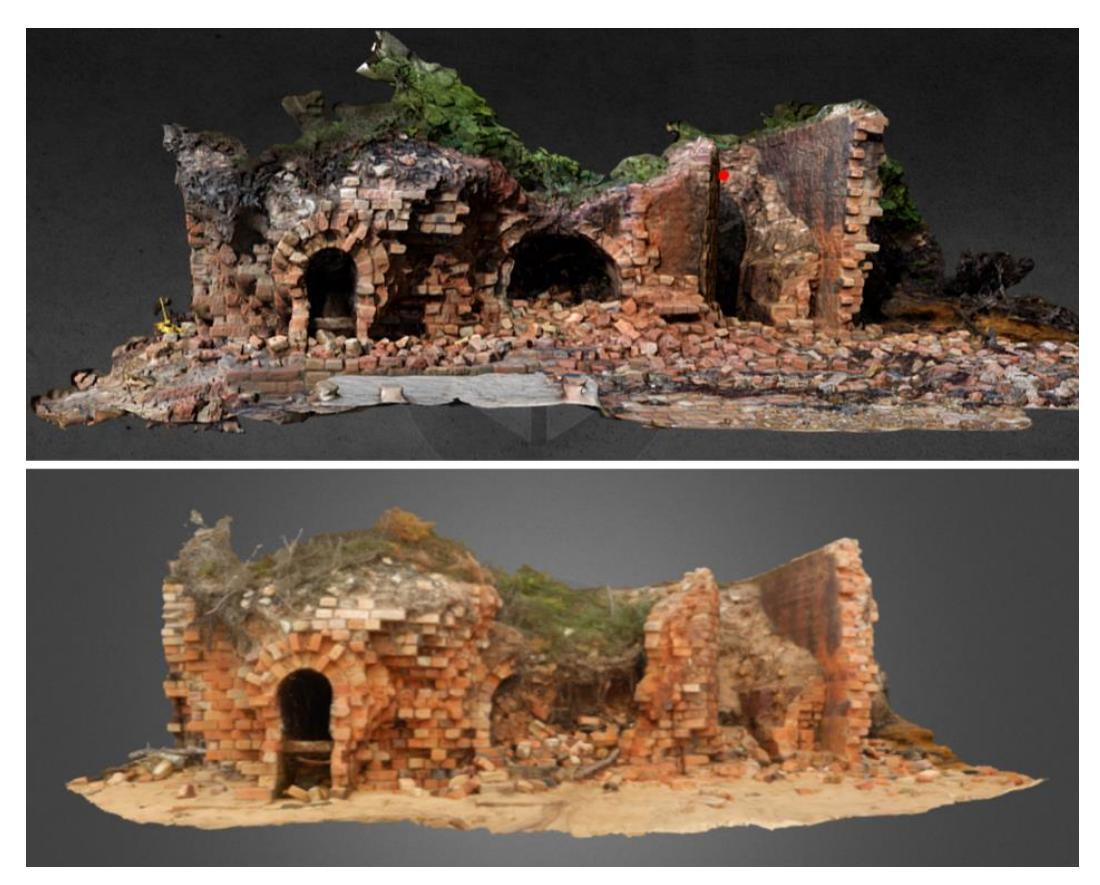
Figure 23: Comparison of the 2015 3D model of Barnes Brick Kiln (top) with the 2016 model (bottom). The main brick lined kiln has collapsed in the time between the models being created.

All three of the features recorded on the southern shore are deteriorating rapidly. This is due partly to the removal of sea defences in 2011 which has led the features to be exposed to high tides and extreme weather events. Alongside this all three of these features, especially 1 and 2, are deteriorating due to visitor erosion. The bricks are regularly removed by visitors and the features are often climbed on. Vegetation above the features has also encroached the bricks and caused them to become more fragile. It is likely that the features will soon completely disappear. In ten years approximately three quarters of feature 1 has been lost. The site is extremely fragile and another major storm event is likely to cause it to be totally destroyed.

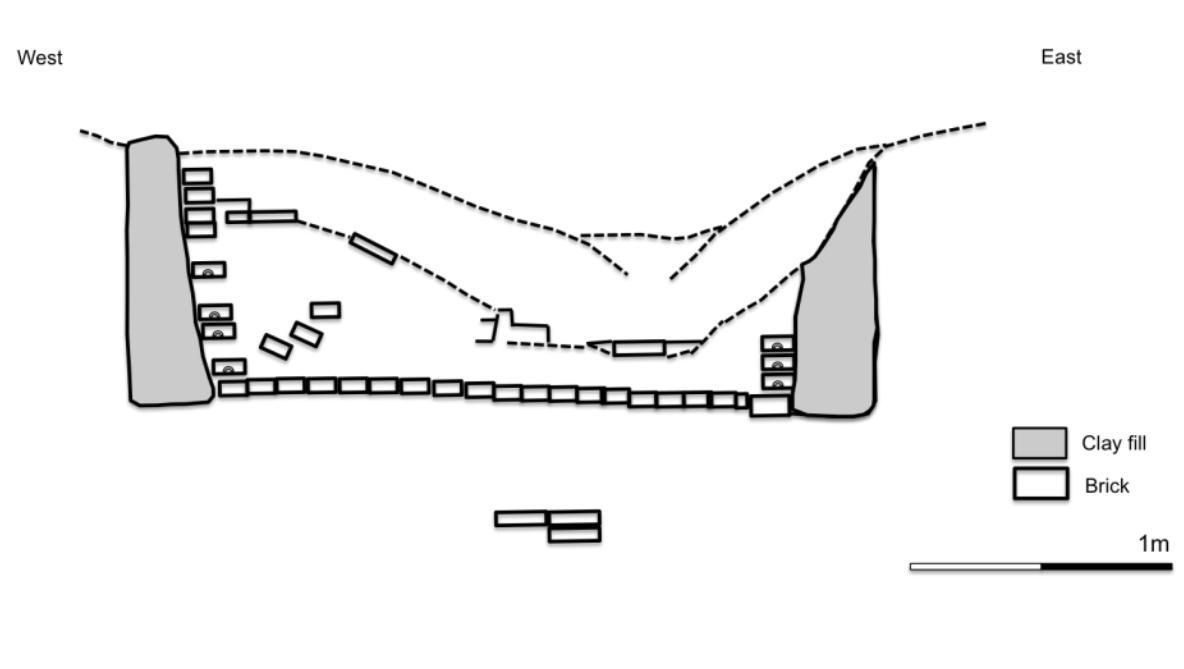
Brick Lined 'Tank'

The feature was recorded in 2016 as part of the two-day training session with National Trust volunteers. A baseline was set up and the feature was drawn using offsets to a scale of 1:20 (Figure 24). Due to time constraints the feature was only recorded in section. However, in 2005 and in 2008, the site was also drawn in plan view which showed over 1m of the tank survived into the cliff with an adjacent brick surface surviving up to 2m into the cliff. The adjacent brick surface has since been lost, as has most of the feature.

Figure 24: Section drawing of the Brick lined tank (Feature 2). Created during the 2016 CITiZAN training event by National Trust volunteers using offset survey.

The brick-lined tank and kiln pit will inevitably be lost through continued erosion, and monitoring of this is recommended, particularly with ongoing photographic survey to record the change over time. The exact purpose of the brick-lined tank has been debated, so further research to compare this with potential similar features exposed on our coastlines would prove valuable. Continued field walking along this section of shoreline is also recommended in order to identify potential further sites exposed as the small cliff retreats. Other features were also recorded during the 2005 survey such as the kiln at Hitchcocks (Papworth, 2005). These are being monitored by National Trust volunteers but would benefit from 3D modelling and/or offset survey to understand and quantify the extent of change over time.

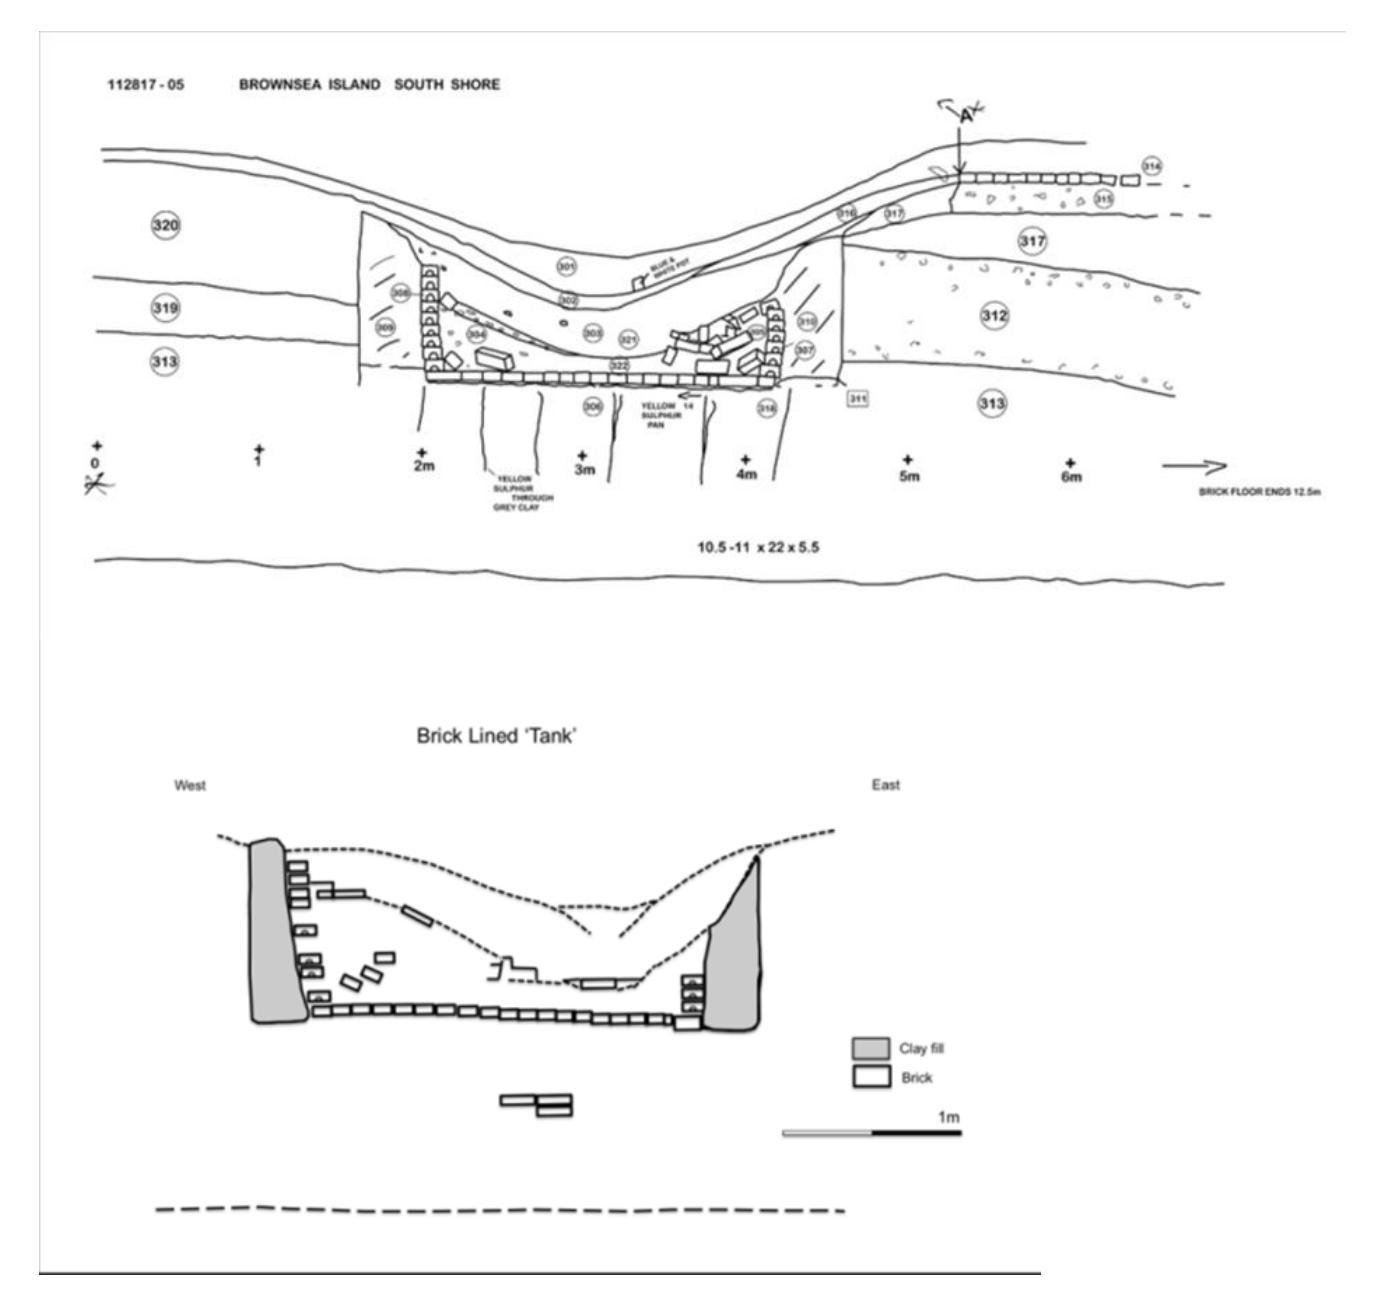
Figure 25 and **Error! Reference source not found.** compare the 2005 and 2008 drawings with the 2016 drawings and photographs. Photographs taken during a monitoring visit in 2017 show the site to have deteriorated even further, however it is thought this is primarily due to visitor erosion rather than natural processes. All of the hollowed-out bricks had been pulled out of the cliff face and piled onto the foreshore.

Figure 25: 2005 section drawing of the Brick Lined Tank (above, drawn by the National Trust and digitised by CITIZAN) compared to the 2016 CITIZAN survey drawing.

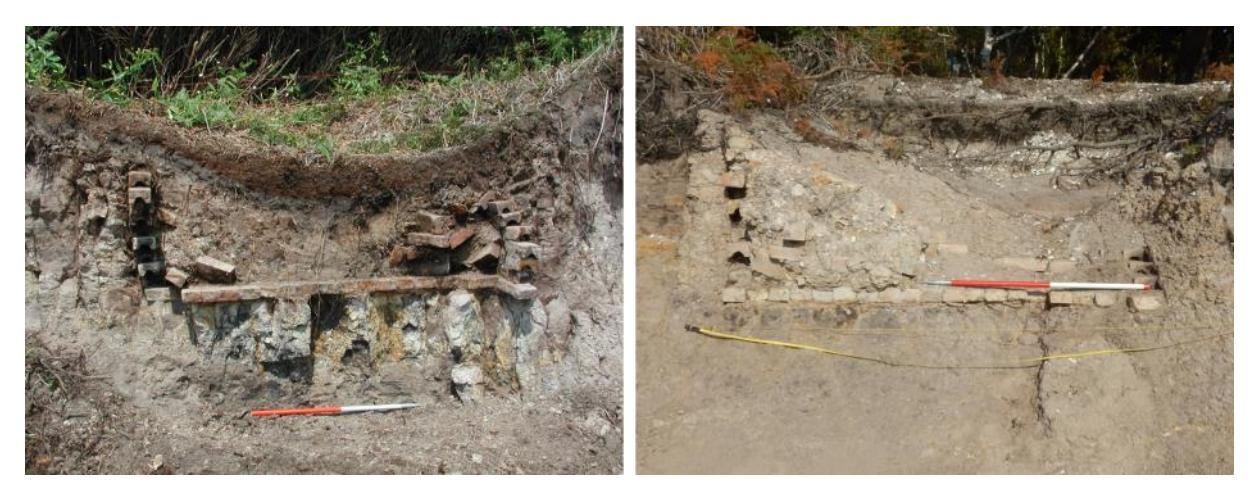
Figure 26 Left: Photograph of the Brick Lined Tank in 2005 (National Trust). Right: Photograph of the Brick Lined Tank 2016.

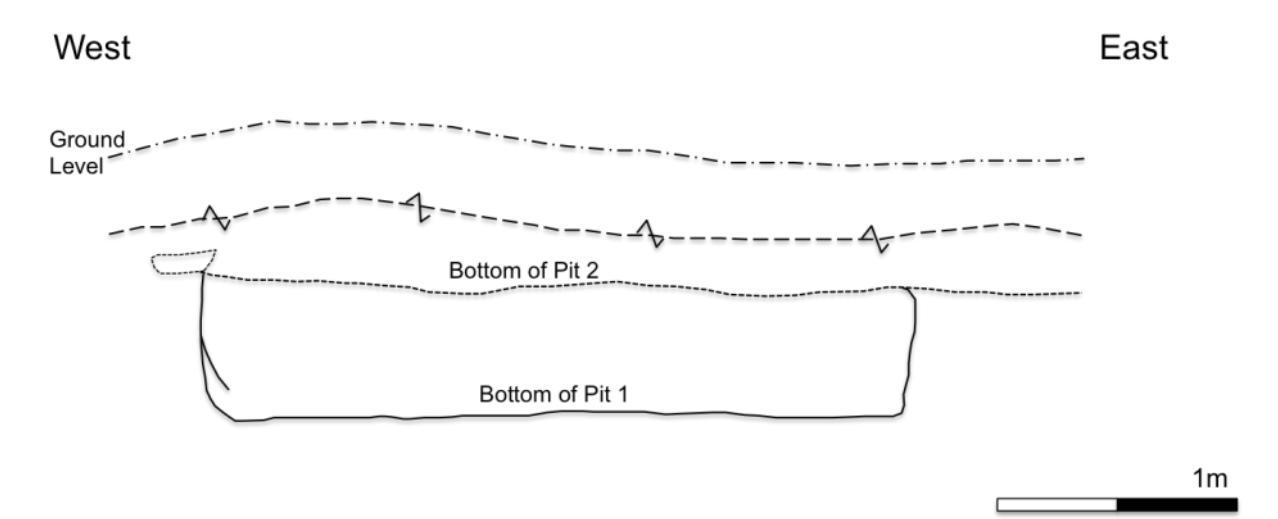
Figure 27: Section drawing of the Kiln (Feature 3) created during the 2016 training event by National Trust volunteers.

Comparisons between the 2005 and 2016 surveys show that this has suffered from some erosion and the square ridges are no longer visible (**Error! Reference source not found.**). There is also increased vegetation at the top of the cliff which may also impact the feature.

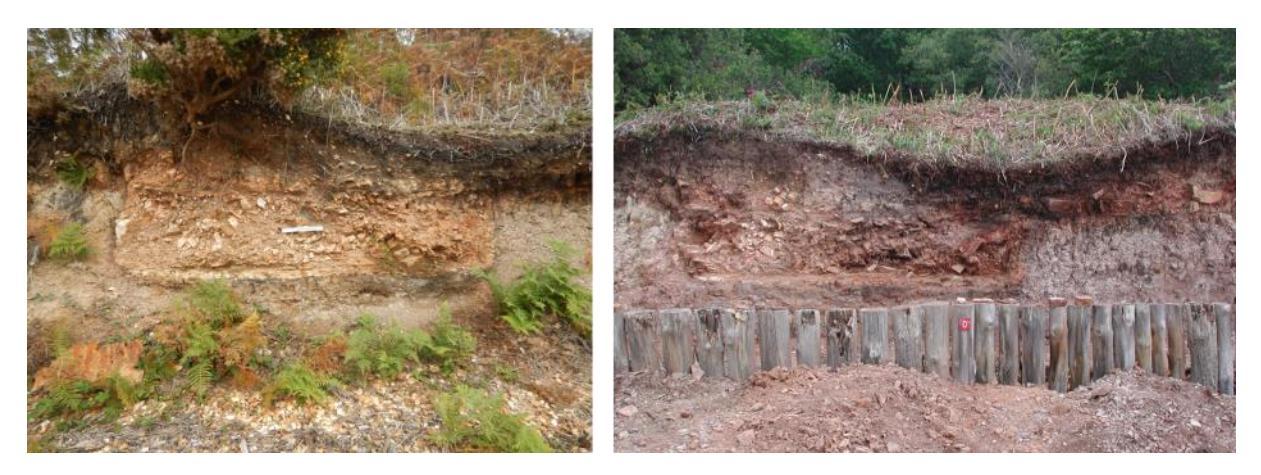
Figure 28: Left: Photograph of the kiln in section (2016). Right: Photograph of the kiln in section (2005, National Trust).

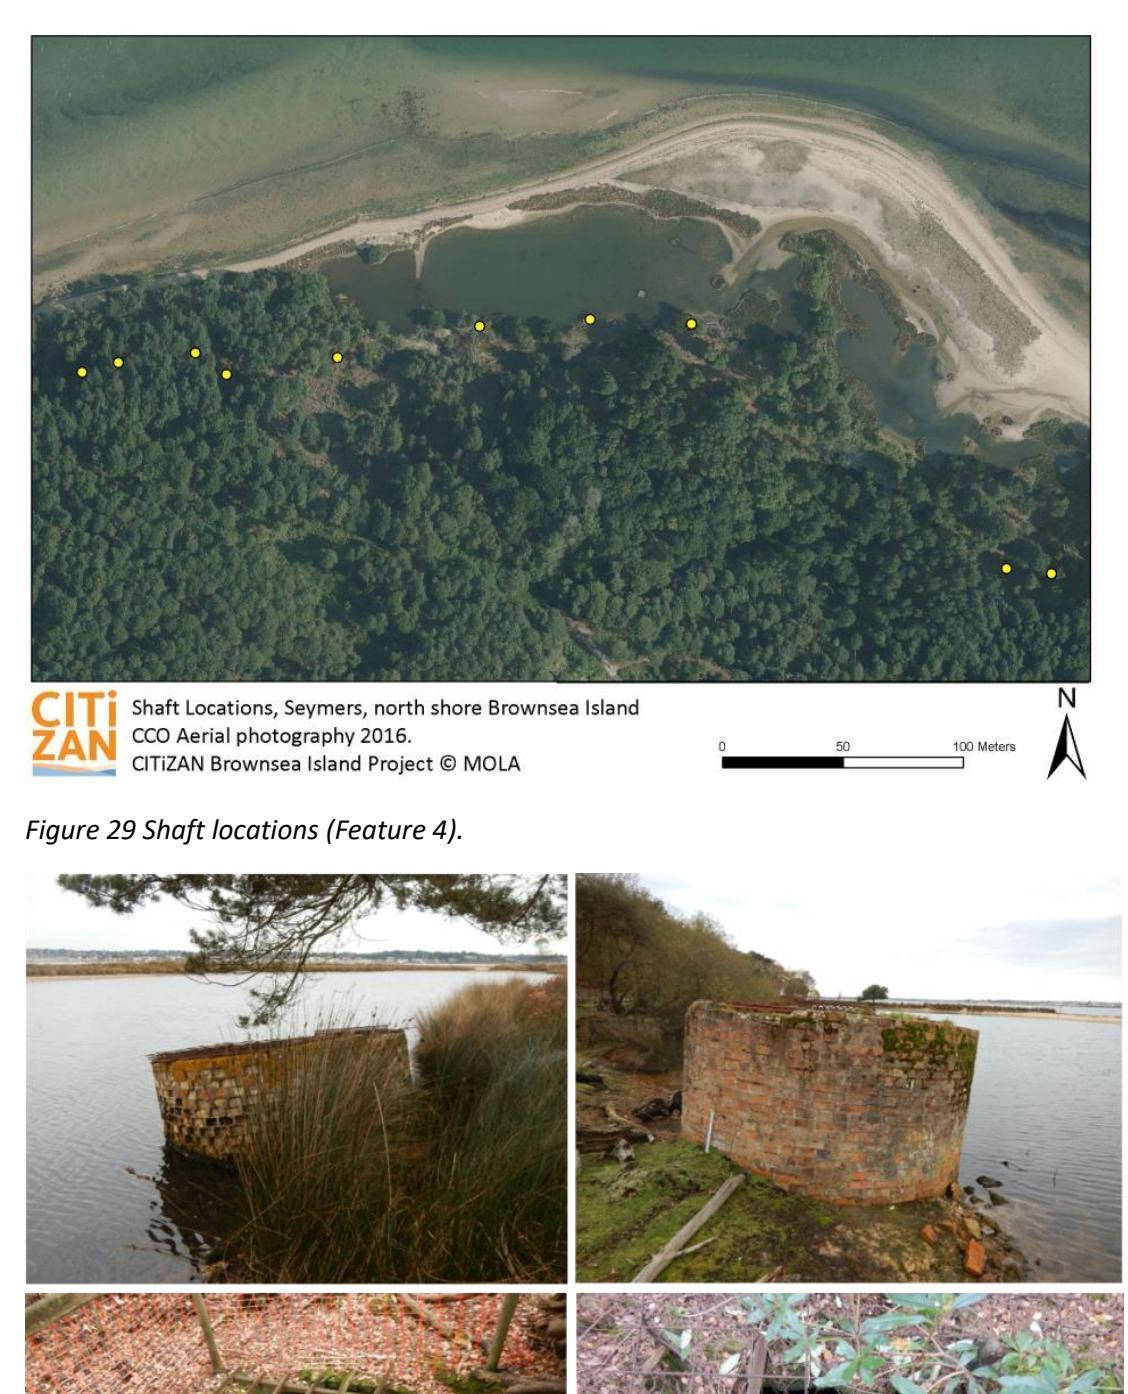
Figure 30 Photographs of the shafts at Seymers taken in 2017. Top left demonstrates the spalling on the bricks caused by the sea. Bottom left shows a circular ground level shaft and bottom right shows the timber lined square shaft.

The bricks on the upstanding shafts have been heavily spalled (Figure 30), particularly on the shafts which are partially submerged. Despite this the shafts are in relatively good condition; this may also be due to the area being located with the conservation zone and rarely visited.

The work carried out on the northern shore showed Feature 4 to be in relatively good condition, with general decay caused by weathering and water damage to the bricks. The nature of the shoreline has also led to better rates of preservation compared to the southern shore as it is more protected from the prevailing winds and the marsh protects the intertidal shafts from storm damage.

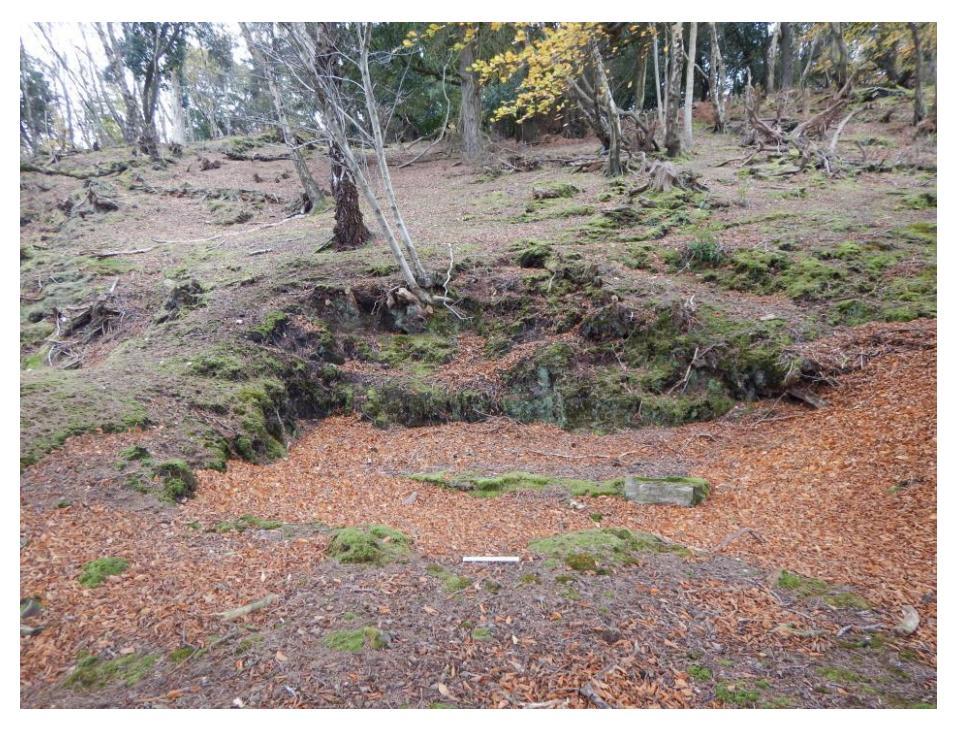
Also within the area of the shafts are the remains of clay pits cut into the cliff below Seymer's Cottage. These were photographed during the 2017 site visit (Figure 31). Within Seymer's marshes are some upstanding metal remains which were also photographed (Figure 32). Comparing the location of these with historic maps shows that it could be related to the route of the tramway and associated pier (**Error! Reference source not found.**). Further work is needed to clarify this.

Figure 31: Photograph of one of the clay pits at Seymers taken in 2017.

The northern shore requires further survey work with the Dorset Wildlide Trust, including a visit during an extreme low tide to search for the pier remains and to track any potential remains of the tramway. Further up the cliff overlooking Seymer's marshes are the remains of Seymer's Cottage, built by Sir Charles Chad in the 19th century and re-used as a home for the pottery manager. Due to its location in a conservation area it has not been demolished like Maryland Village, but it is deteriorating rapidly due to general structural decay. It is recommended that a 3D model of the cottage and associated outbuildings be created to preserve the site by record.

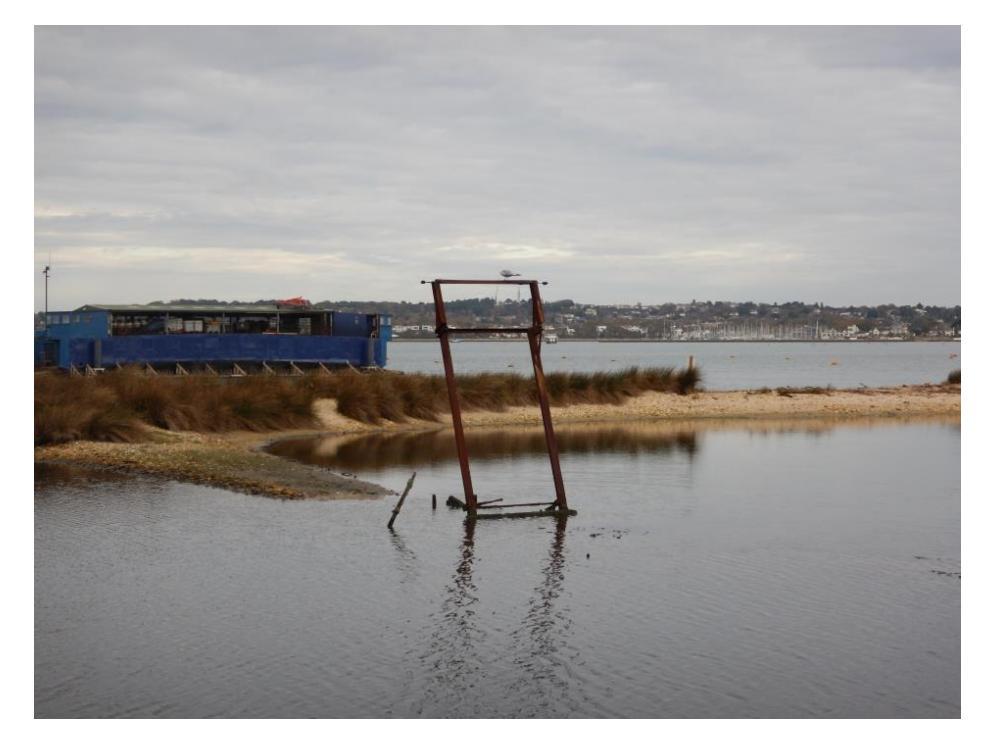
Figure 32: Photograph of the metal remains at Seymers, this is along the route of the tramway and may be associated. Image taken in 2017.

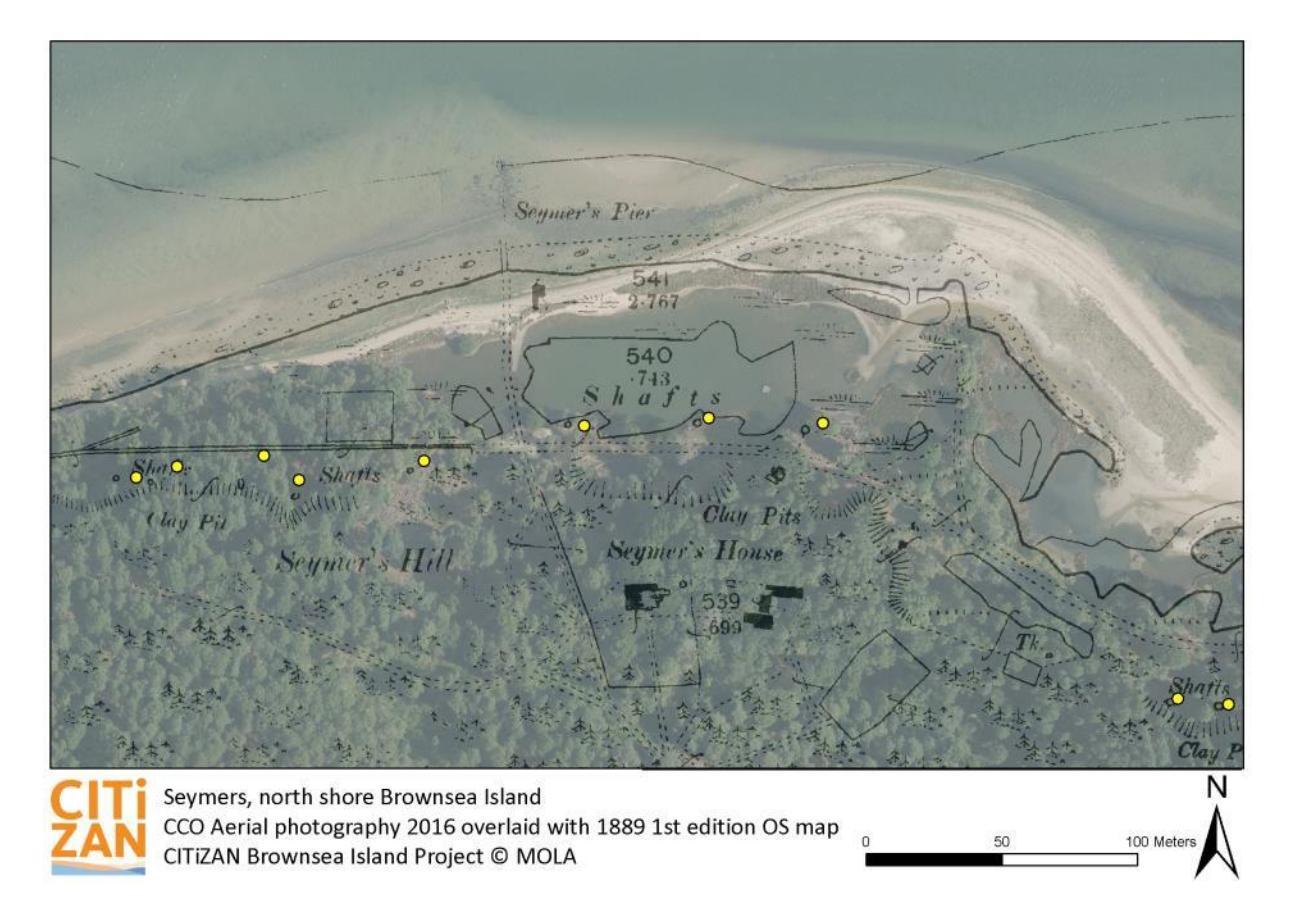
Figure 33: Current aerial photograph of Seymers with 1889 OS mapping overlaid showing the location of the tramway and pier. Further work is required at low tide to see what may survive of these features.
