**Foreshore survey at COALHOUSE FORT PARK
Princess Margaret Rd
East Tilbury
RM18 8QD**

Report on a CITIZAN site survey

Summary

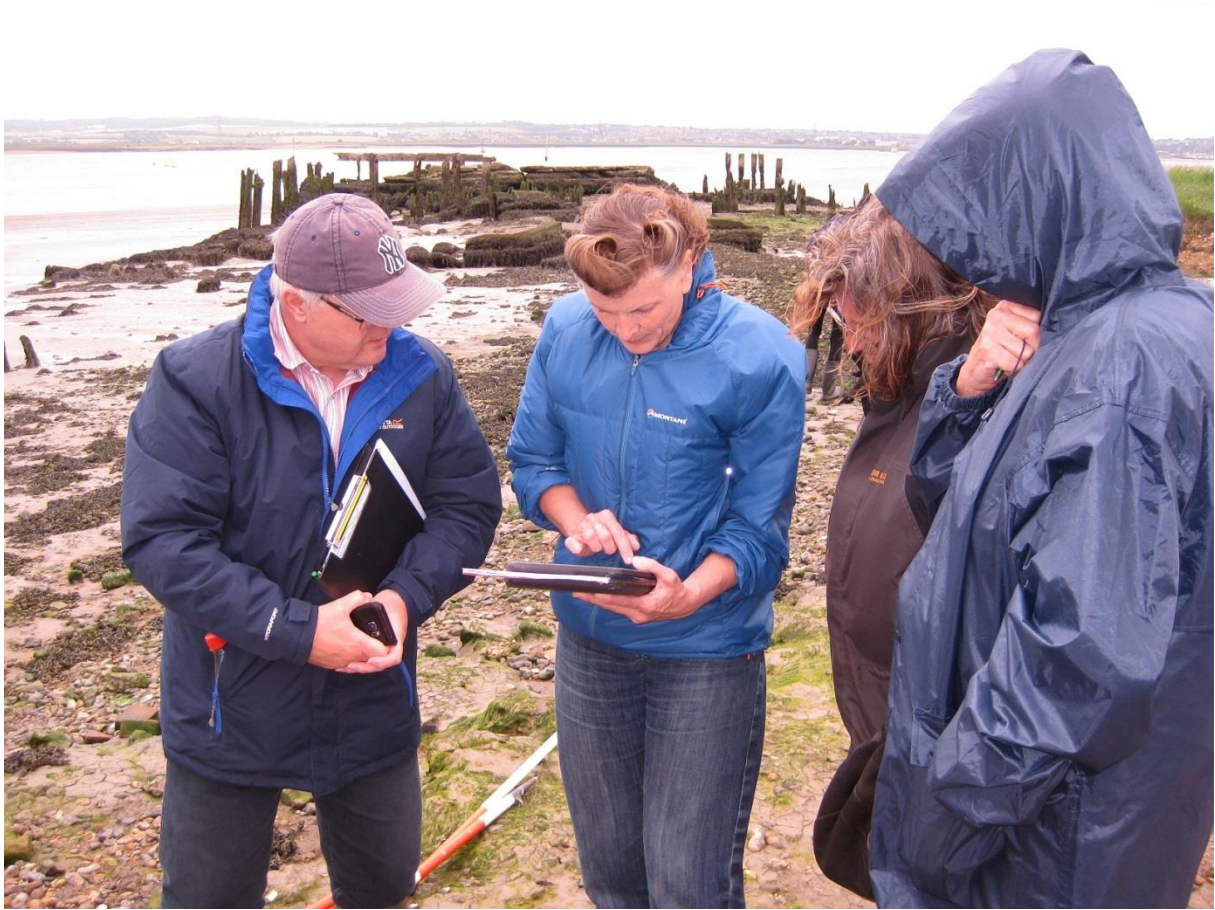
Figure 3 CITIZAN app workshop, June 2016 (Image: Hazel Sacco)

In June 2016 a CITiZAN App workshop was carried out on the site in lieu of a full training event that summer (Figure 3). 16 people attended, 3 of whom subsequently came to the training weekend in May 2017. CITiZAN were assisted in this survey by MOLA geoarchaeologist Jason Mole who gave an insight into the geoarchaeology of the site.

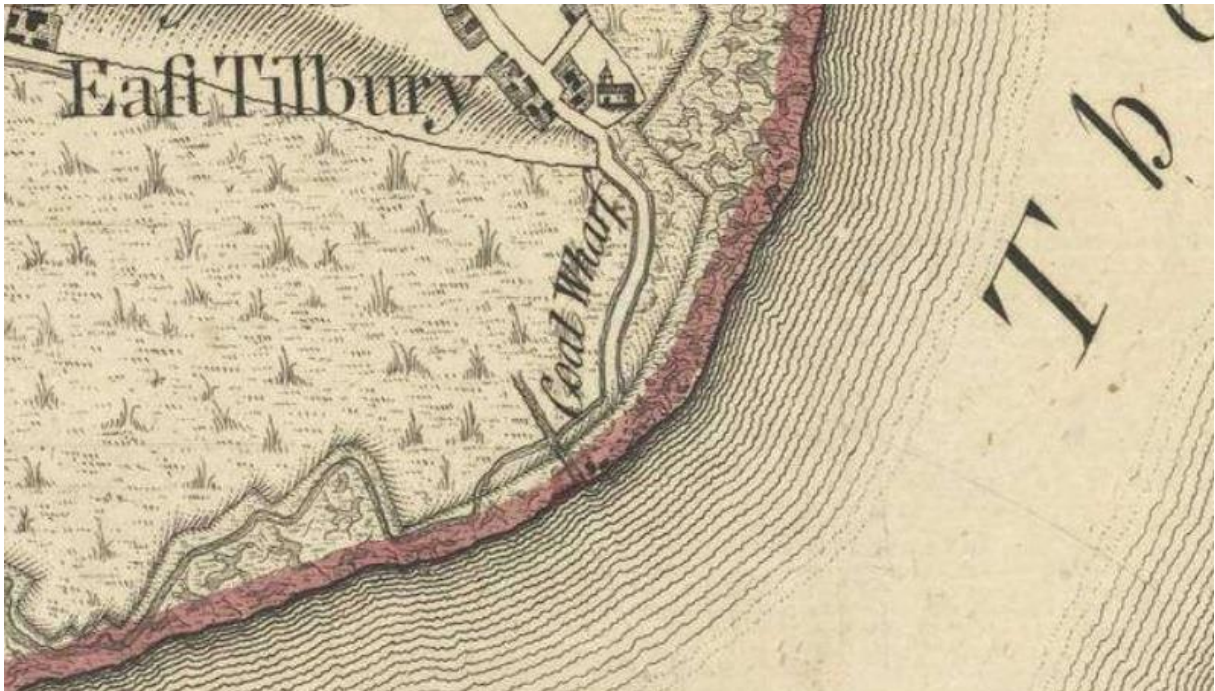
Figure 4 Excerpt from Chapman & Andre's Map of the County of Essex, 1777 (Image: Biblioteca Virtual del Patrimoni Bibliogràfic)

A ferry at this point may have continued until the 18th century (Brown and Pattison 2003). Chapman and André's map of 1777 (Figure 4) shows a drainage cut with two possible structures just to the east, labelled Coal Wharf. The Ordnance Survey map of 1805 shows two buildings differentiated by colour, labelled Coal Ho[use] Flag (Figure 5) though these appear to be either side of the drainage cut. The Coal Wharf buildings are shown in more detail on the 1838 Tithe Map with three buildings sitting inside two rectangular enclosures, the boundaries of which are probably drainage ditches (Figure 6). According to the Tithe Apportionment book the wharf is owned and occupied by the War Department. The Coal Wharf is recorded in Essex HER as MEX1037623.

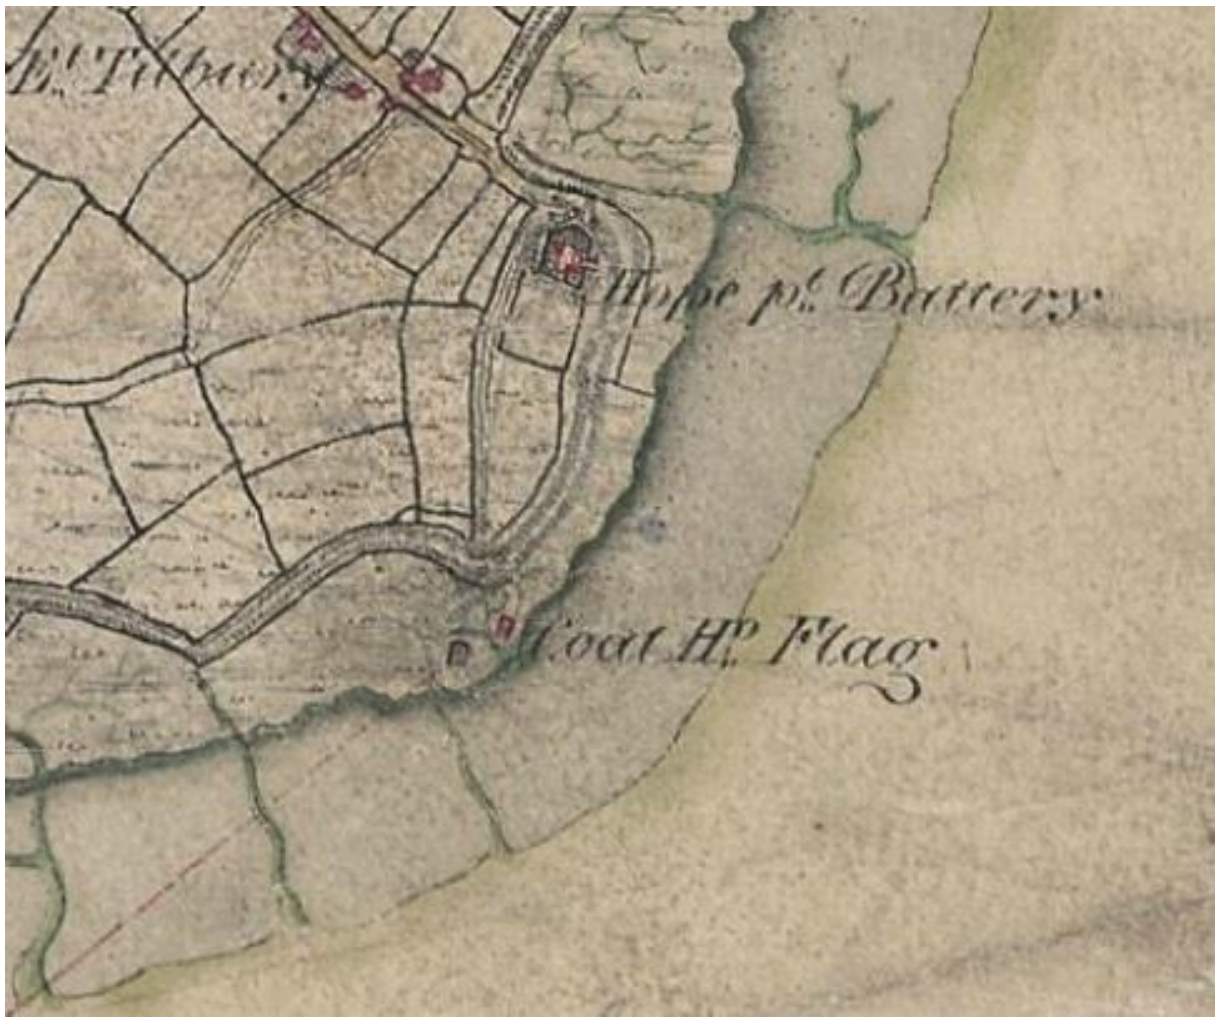
Figure 5 Excerpt from the 1805 Ordnance Survey map of Essex (Image: British Library)

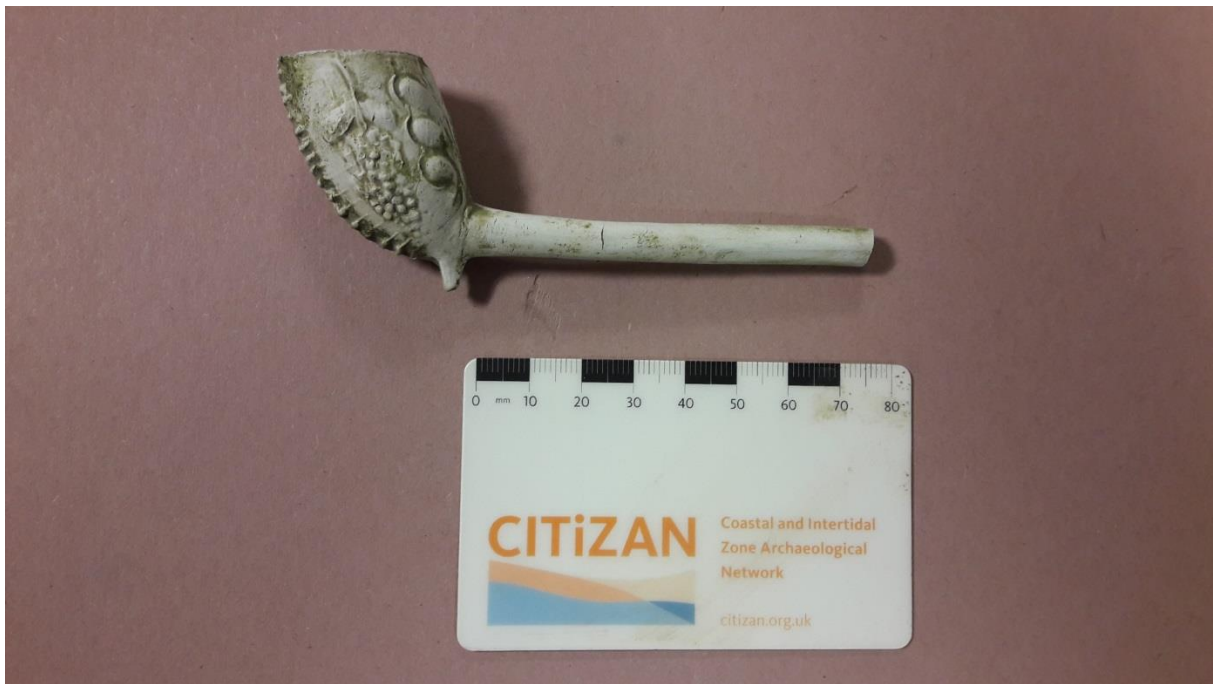
Figure 7 The clay pipe found on the foreshore during CITiZAN's preparatory survey, February 2017

During the CITiZAN preparatory survey, 16 February 2017, we found a clay pipe lying in the coal wharf area. It was unabraded so had clearly recently eroded out of the mud flats or salt marsh (Figure 7). It is not in the remit of CITiZAN to collect finds and objects should not be removed from SAMs without permission but as the pipe was lying on the surface and could easily have been lost to the next tide or to a curious visitor the decision was made to retrieve it, record it and deposit it with Thurrock Museum Service. The pipe probably dates from 1800-1830 and from the style of decoration, probably comes from the north east of England, likely having arrived with a coastal shipment of coal from that area (David Higgins, National Pipe Archive, pers. comm; Higgins 2006). A record of the pipe was lodged with the Portable Antiquities Scheme (Unique ID CITiZAN-1A2B74).

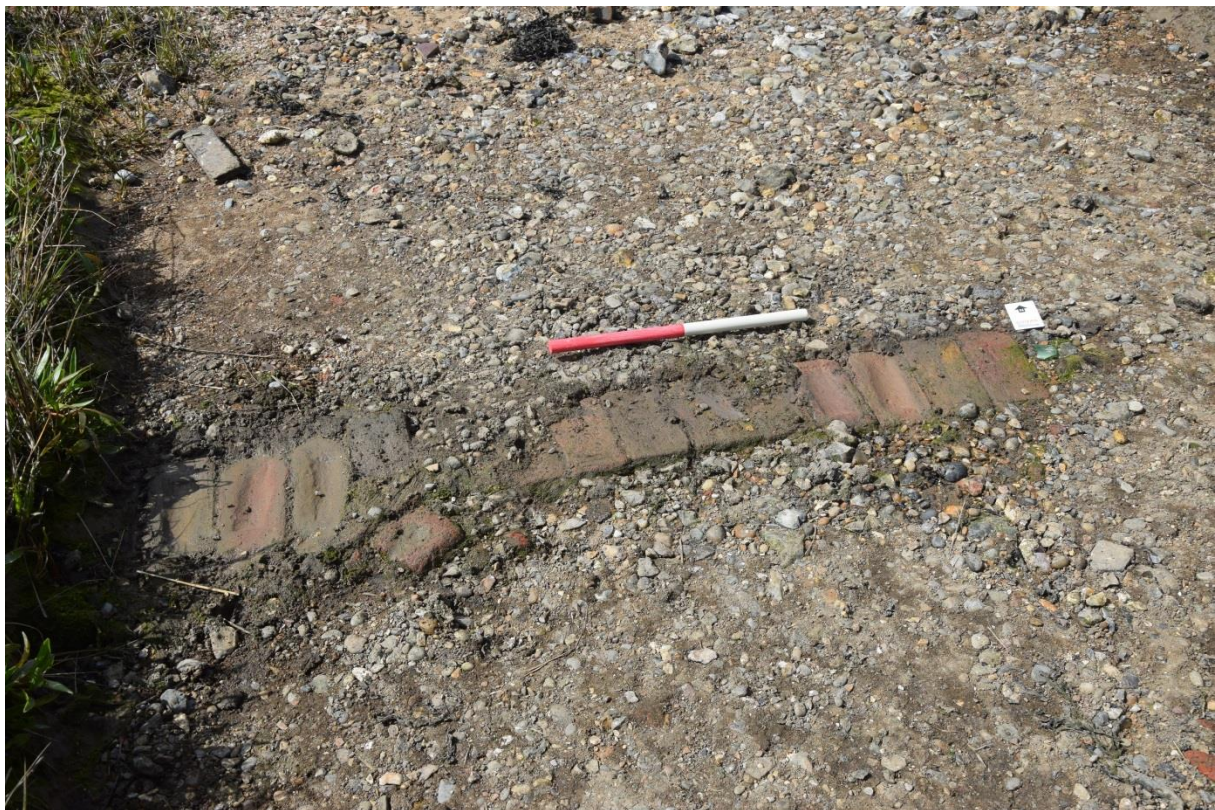
Figure 10 Area 1: the line of bricks

A single line of 12 red handmade bricks, laid with stretchers adjoining, visible for 1.7m on an east-west orientation (Figure 10,

Figure 11). The line starts in the middle of an area of mudflat and shingle and runs into the saltmarsh to the east. It lies embedded in the tidal flats at c 1.8m OD. The bricks are all 220mm long by 100mm wide; their thickness could not be measured without disturbing the bricks . Some of the bricks have a shallow frog, some have no frog. There is no sign of mortar on any of the bricks. No construction cut was visible.

Though the date of the bricks, even if it could be defined, would not necessarily date the structure a tentative suggestion is that this line of bricks is associated with the early phase of coal wharf buildings noted on historic maps from 1777. It may be the lowest level of a foundation; the single skin of bricks suggests a fairly lightweight structure.

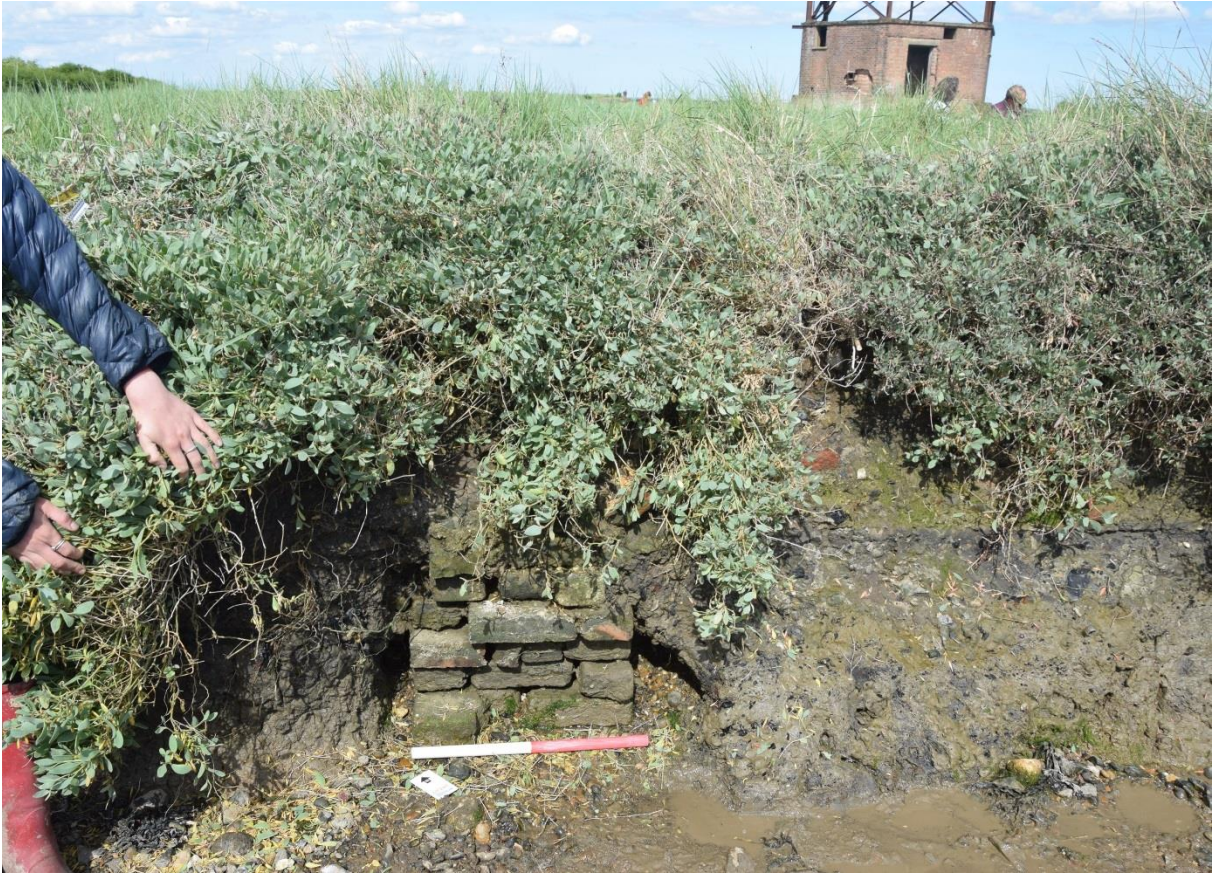
Figure 12 Area 2: Brick feature and surrounding contexts

The form and materials of the brick structure suggest it is part of a trench built foundation of reused bricks. From the relationship with the brickwork in Area 4 it seems likely that these formed part of the foundation of a building measuring at least 5m x 6m with the long axis orientated SE – NW. The inclusion of a high amount of charcoal and coal in the surrounding contexts suggests this was associated with the coal wharf noted on maps from the late 18th century.

The top of the brickwork is level with the interface between contexts 3 and 2. It seems possible then that the building supported by the foundation wall was demolished to the height of the extant brickwork then the ground above raised with deposited material. The very clear and straight dark line at the interface of context 2 may indicate a former floor/working surface, i.e. the building was demolished to floor level.

The void either side of the bricks is likely to be the cut for the foundation, with the backfill removed by tidal scour. It appears to have been cut through a relatively charcoal/coal rich deposit suggesting that the building was constructed on made ground, or at least disturbed ground, after the coal wharf had already come into use.

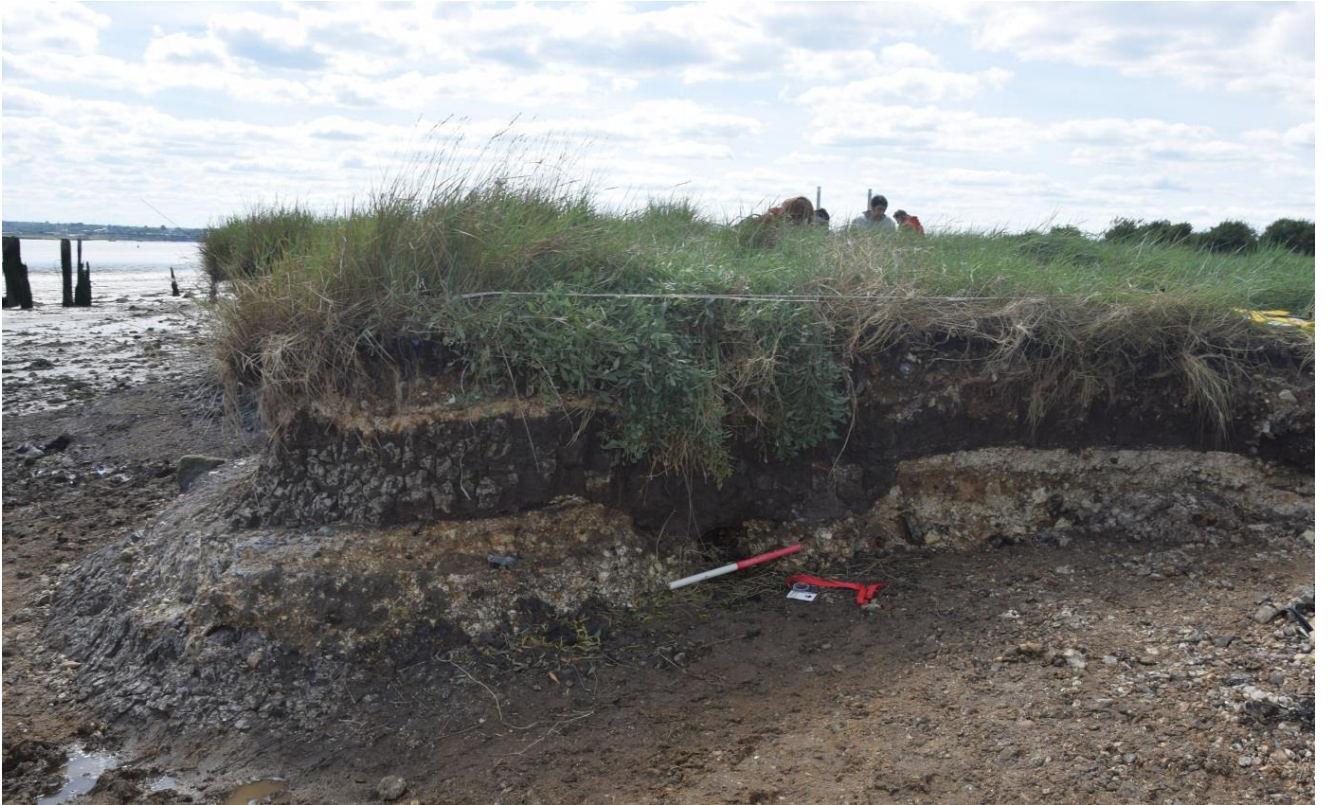
Figure 14 Area 3: made ground

Area 3 was found to be very similar in make up to that described in the 2003 report though from a comparison of photographs has clearly suffered from erosion since then..

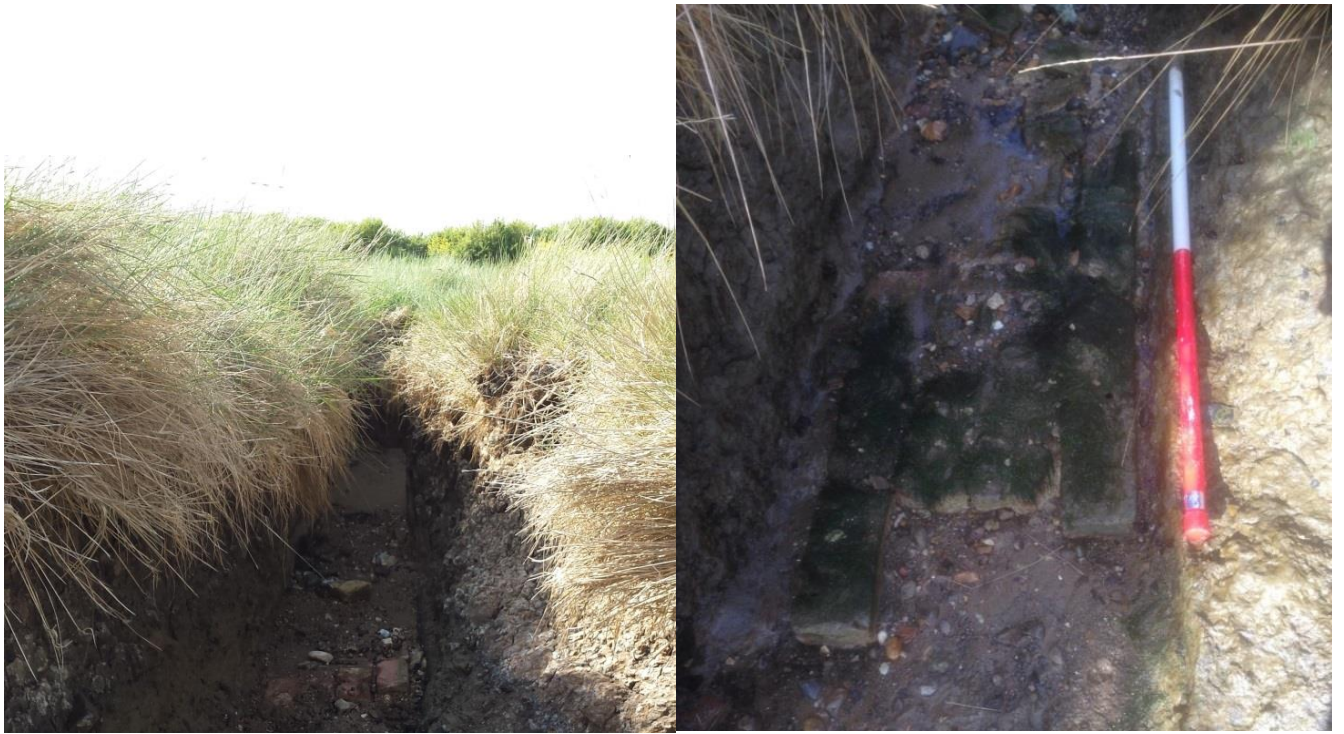
Figure 16 Area 4 in May 2015 (left) and February 2017 (right)

During the site visit in May 2015 a laid area of red handmade was noted at the base of a narrow inlet in the saltmarsh. This lay just to the east of Area 2 (also noted in 2015) and at approximate right angles to it. This area of brickwork was also noted during the preparatory survey of February 2017 though with yellow London stock brick laid in running bond and, again, covering the base of the narrow inlet. The brickwork was four headers wide east – west and at least 4 stretchers long north-south. This area was to be one of the targets for recording for May 2017 survey but was no longer visible.

During the May 2017 survey however two or three horizontal bricks were noted in east facing elevation of this inlet, roughly in line with the brick feature recorded in Area 2. The general position of this feature is recorded on Figure 2, and photographs taken in May 2015 and February 2017 are included for reference (Figure 16).

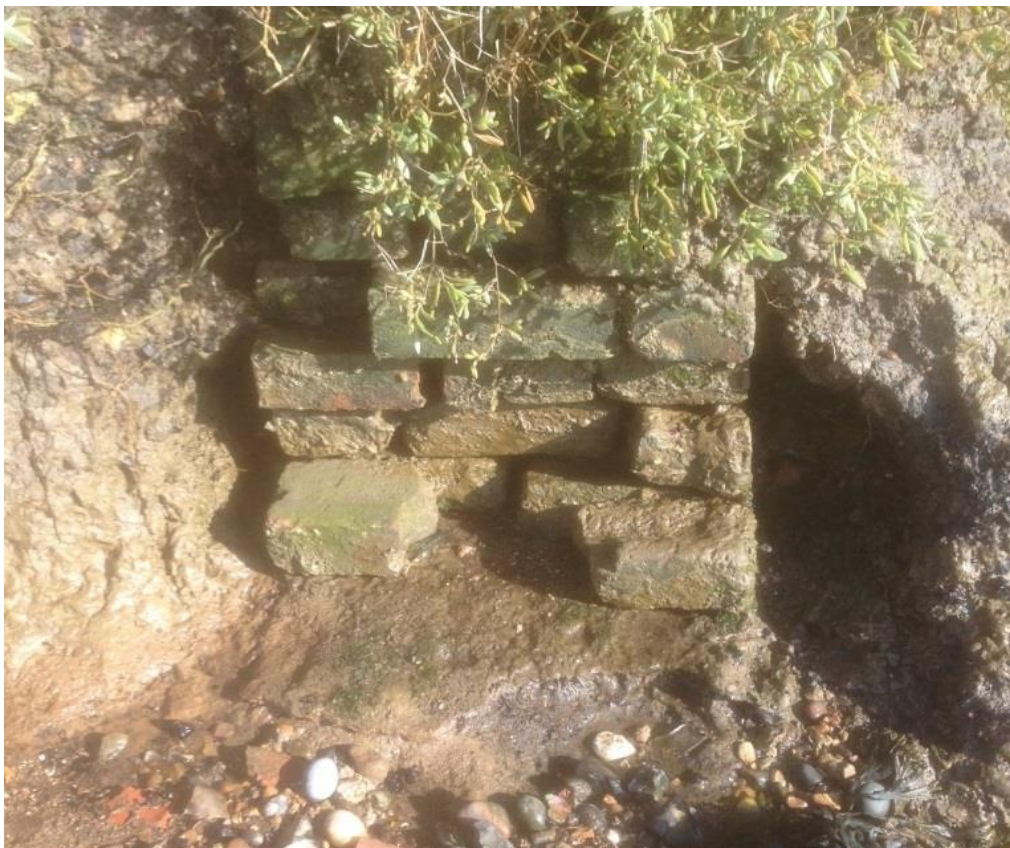
Figure 17 The layer extending westwards from the brick feature, possibly a bed of mortar, February 2017

The thin smooth layer under the bricks observed extending beyond the bricks in May 2015 and February 2017, but no longer visible may have been the remains of a bed of mortar at the base of the trench (Figure 17).

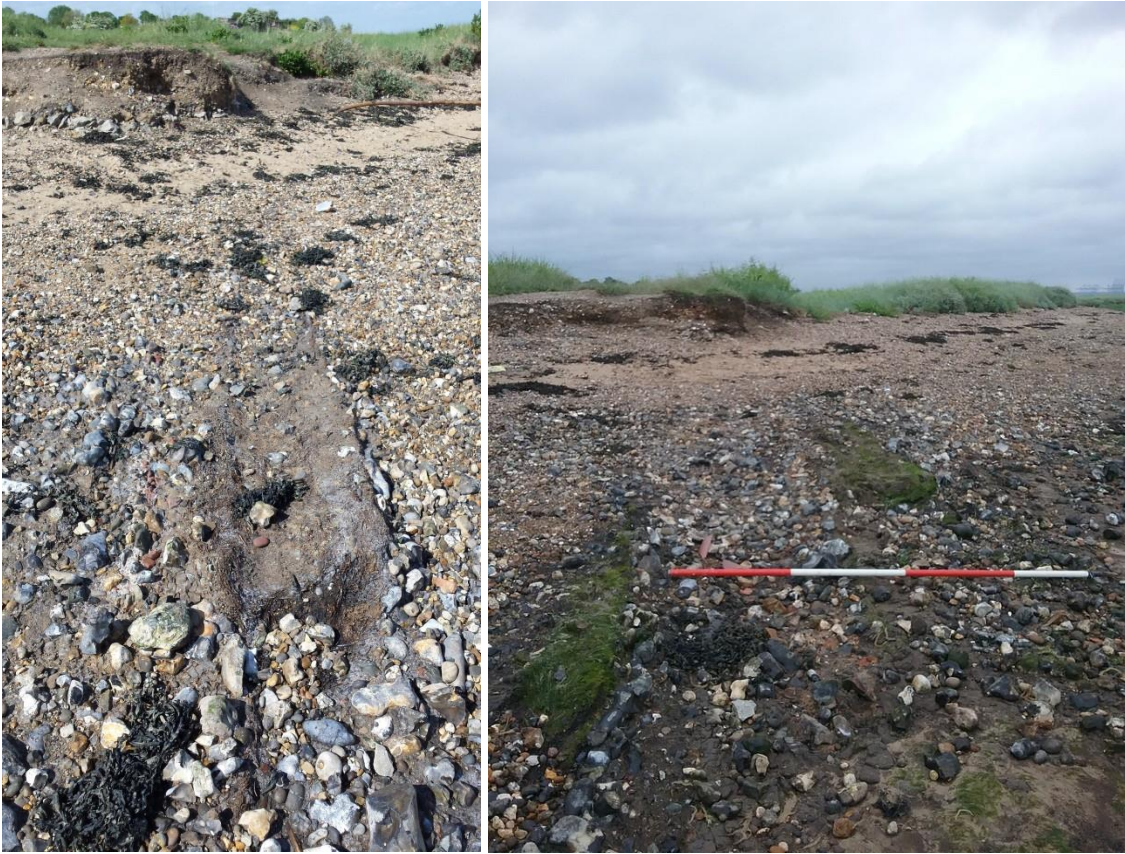
Figure 18 Lines of brushwood on the foreshore in May 2015 (left) and June 2016 (right).

Not covered in this survey but noted in February 2015 and June 2016 the former tramway had lost a sleeper on the edge of the intertidal zone. The brushwood (Figure 18) following south west from the end of the tramway into the intertidal zone also became much more visible over this period. The DGPS survey carried out in February 2017, which forms the basis of Figure 2, also highlights erosion along coast edge foreshore to the immediate south west of the tramway path.
