**Earl Grey's bathing pool  
Howick foreshore**

County of Northumberland

April 2018

Report on a CITiZAN site survey

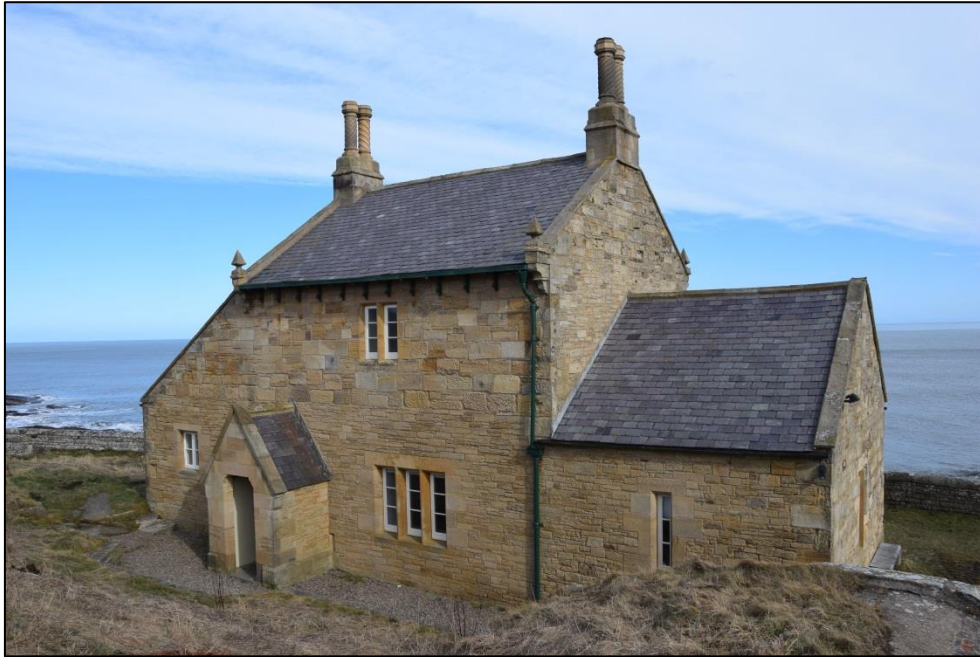
Fig 3: The Bathing House, view to the Northeast

In the 1840's Earl Grey requisitioned an extant house on low cliffs overlooking the bay known as Rumbling Kern. The building was converted into what became known as the Bathing House (a Grade II Listed Building – LB 1041801; PRN N14250. See Fig 3) and the Greys installed a caretaker on the ground floor. The building is described in Pevsner as being “superbly sited on the rocky coast east of Howick village. An 18th century cottage remodelled in c1840 for the Grey family, with Tudor windows and tall moulded terracotta chimney pots. The salt wind has eaten deep into the sandstone dressings” (Pevsner *et al* 2002, 352).

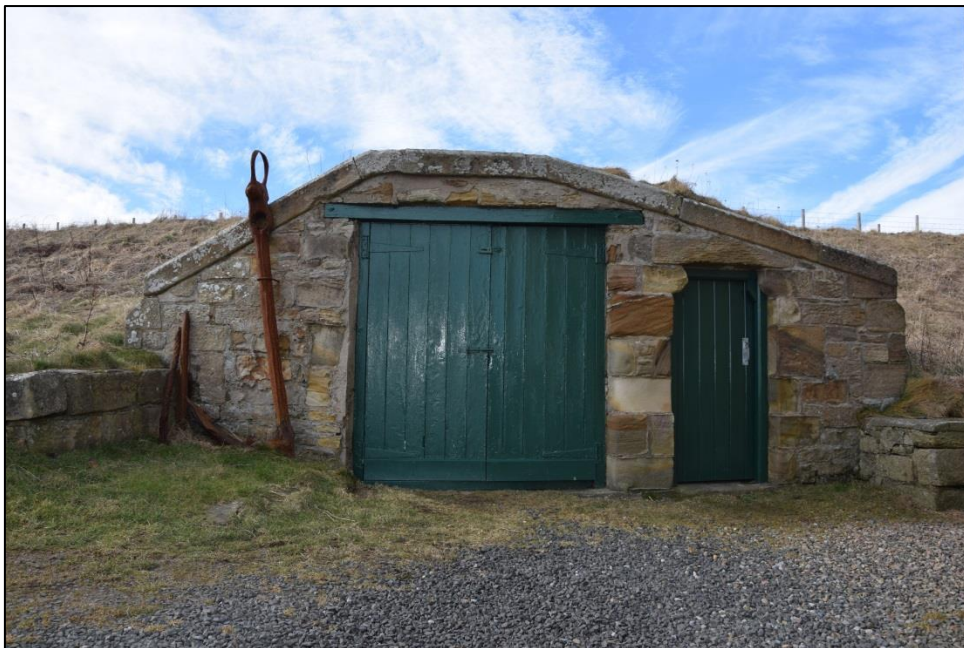
*Fig 4: The Listed outbuilding, possibly a 'coach house', view to the west*

At the same time the house was converted a small coach house was constructed landward of the Bathing House to store a buggy or trap (Grade II Listed Building – LB 1371201; PRN N14250. See Fig 4) and a set of sheltered steps constructed to run through the property’s boundary wall and onto the cliffside (Grade II Listed Building – LB 1153943; PRN N14239. See Fig 5). A pair of bathing pools were cut into the bedrock of the foreshore, possibly at the same time of the construction of the coach house and steps. The first pool (Pool 1) is located to the north of the bluff that the Bathing House stands on and is accessed directly from the grounds of the house. The second pool (Pool 2) is located to the south of the bluff and can be accessed by scrambling down the low cliff from the Bathing House or from the beach adjacent to Rumbling Kern.

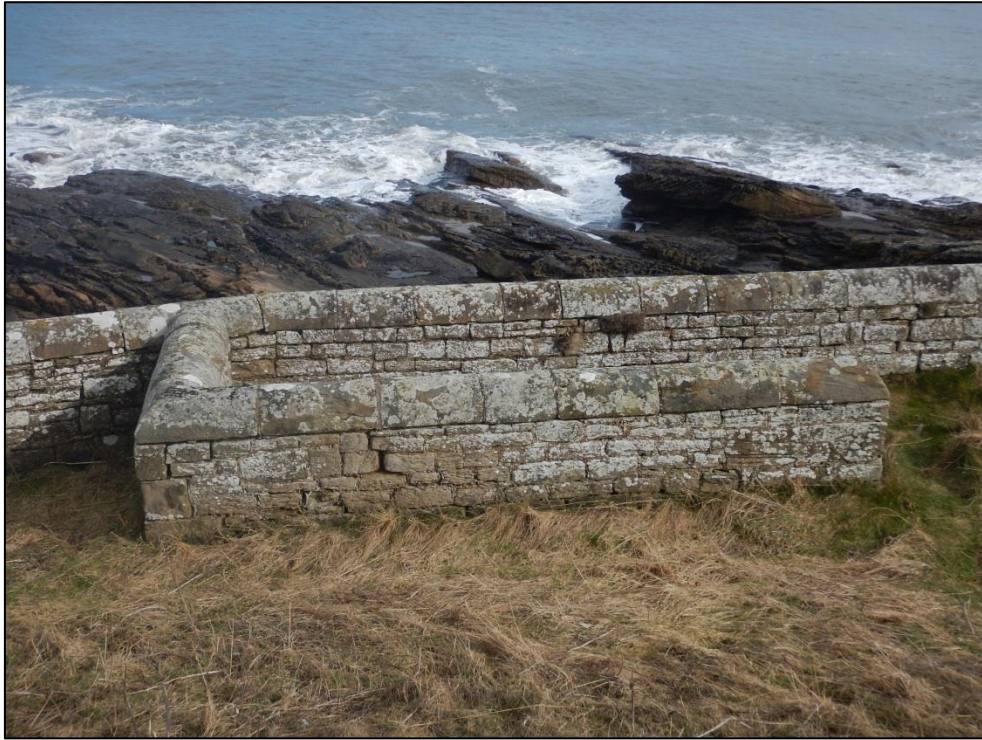
*Fig 5: The Listed wall and steps leading to Pool 1, view to the east*

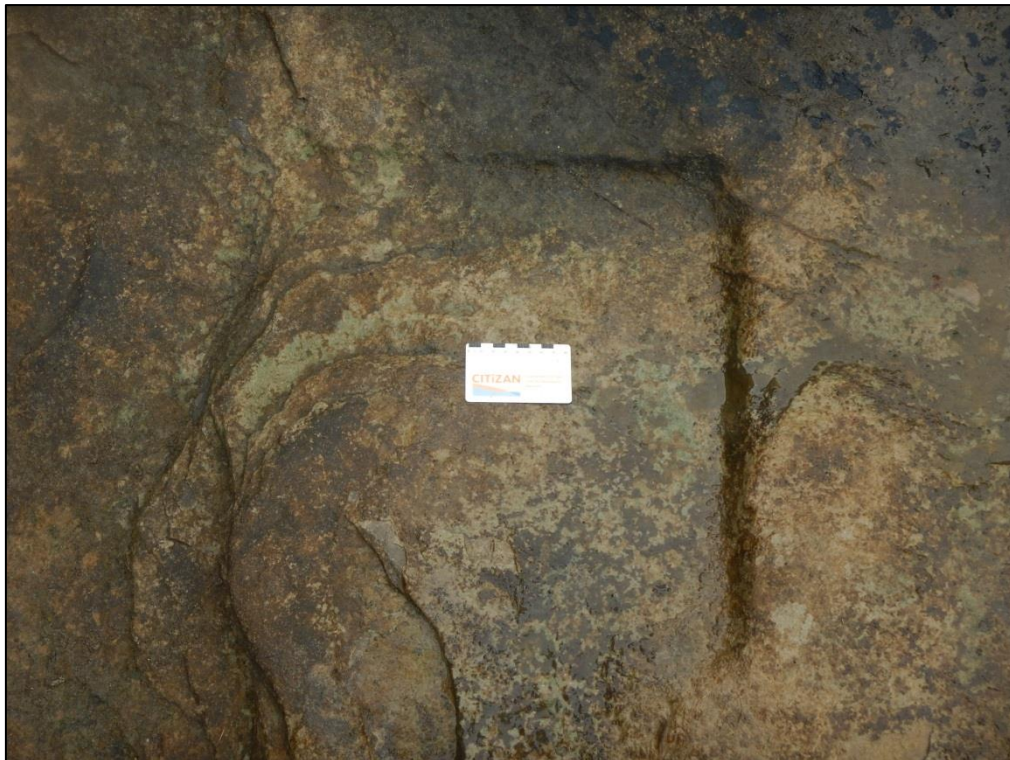
The pool was reached by two short flights of steps and a series of single steps cut into the bedrock (see *Fig 6*) between them. The lower flight of seven steps, that provides immediate access to the pool, measured 2.50m in length, 1.20m in width and fell a vertical height of 1.00m. The average depth of each step was 0.15m. The upper flight of steps was located on private property, and it was not possible to survey them. Connecting these flights of stone built steps were a series of individual steps cut directly into the bedrock, the biggest of which measure 0.35m by 0.40m, with a depth of 0.02m.

While Pools 2 and 3 do not appear to be at immediate risk of erosion the steps providing access from the Bathing House grounds to Pool 1 have begun to erode. Pool 1 is also starting to be filled by large slabs of sandstone that appear to have collapsed from the cliff above the pool.

*Fig 6: One of the rock-cut steps on the foreshore leading to Pool 1*

It is suggested that a detailed survey of the steps leading to Pool 1, the pool itself and the access channel to the sea is conducted using a DGPS in order to create a full record of this landscape before it is lost by coastal erosion.

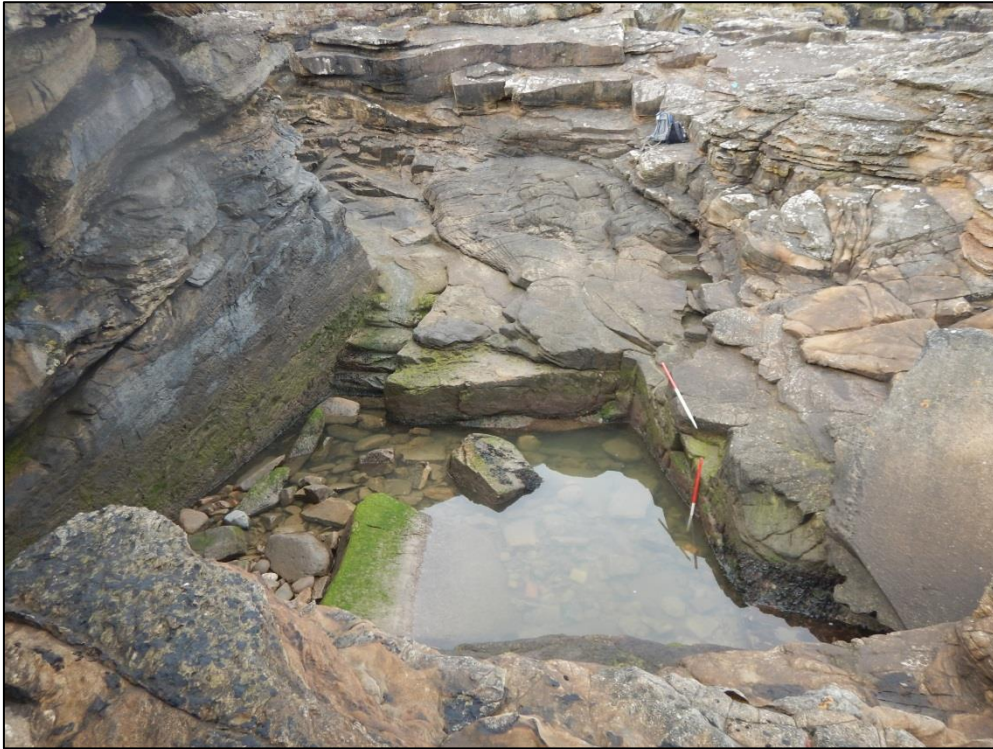
Pool 1 (see *Fig 7*) was a sub-rectangular pool cut into the bedrock at the base of narrow crevice to the northwest of the Bathing House. It was located against the side of a vertical sandstone cliff, with a height of 10m. The pool was accessed directly from the grounds of the Bathing House by several flights of steps, with access from the surrounding foreshore extremely difficult. As a result the pool was highly secluded, not being visible from the surrounding foreshore until the viewer is immediately adjacent to the pool and was not overlooked by the clifftop path.

Pool 1 measured 4.00m by 3.10m in size and had an extant depth of 1.20m. The pool was partially filled with beach rubble and collapsed slabs of sandstone cliff, so it was not possible to establish the full depth of the pool. At low tide the pool contained 0.50m of standing water. The pool was connected to the open sea by a narrow channel that entered the pool in the northeastern corner, on average the channel measured 0.50m by 0.50m (see *Fig 8*).

*Fig 7: Pool 1 showing steps leading down from the Bathing House on the left, view to the west*

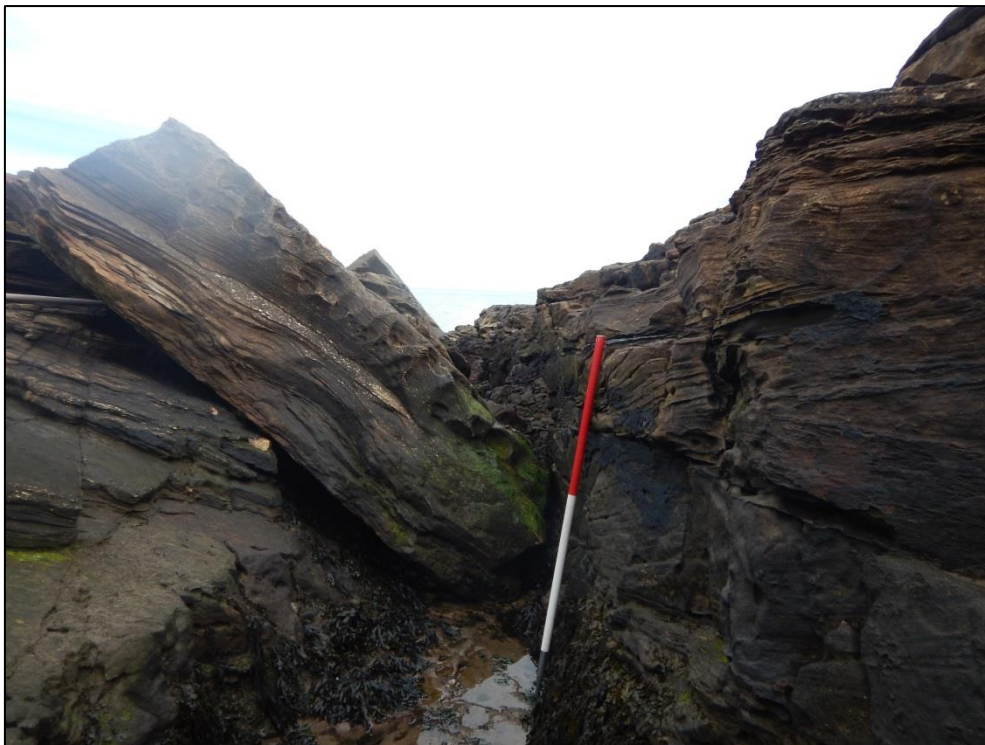
*Fig 8: Access channel from Pool 1 to the sea, view to the east*

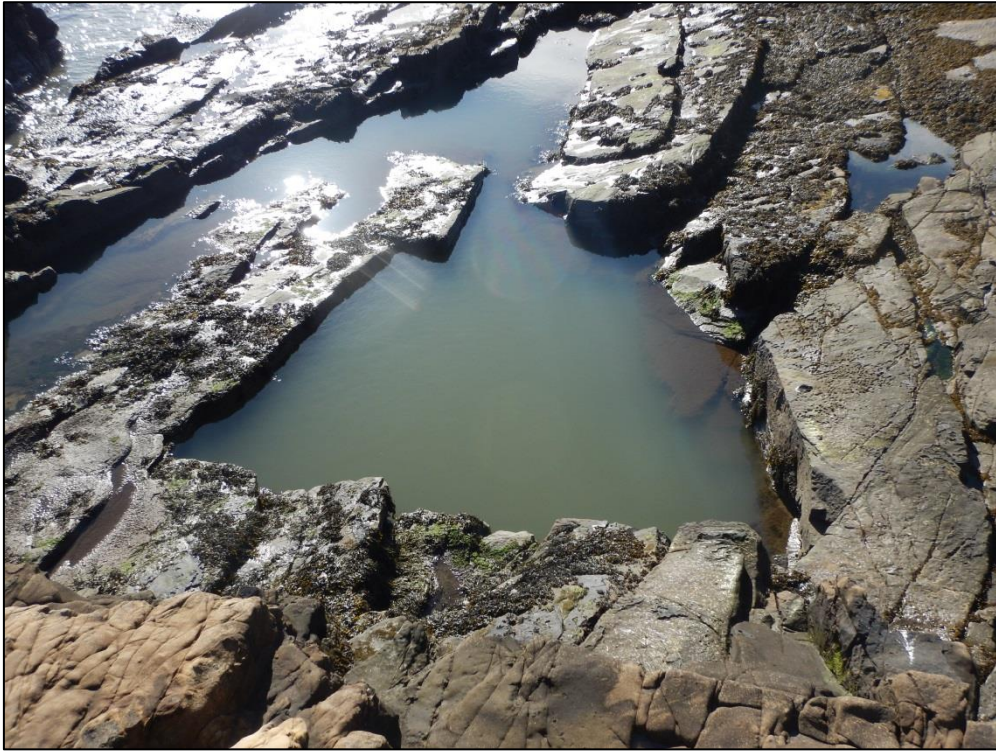
The second pool (see *Fig 9*) was cut into the sloping bedrock of the foreshore to the south of the Bathing House and was overlooked by the clifftop path and the upper room of the Bathing House, the pool was also visible from the sandy bay to the south of the pool.

Pool 2 measured 6.20m by 5.00m in size and had an extant depth of approximately 2.00m. At low tide the pool contained approximately 1.20m of standing water. The northern, western and eastern sides of the pool were all sharply cut, with pronounced straight edges and rounded corners, whereas the southern edge of the pool appeared to have been uncut and seemed to follow the natural slope of the bedrock. A square cut channel joined the southeastern corner of the pool to a shallow, sloping natural crevice which in turn opened into the sea. The channel measured 0.50m in width and approximately 0.50m in depth. Running along the western edge of the pool, below the standing water was a narrow ledge, which appeared to have been cut flat and slightly deepened for a distance of 1.00m. It is possible that this feature functioned as a bench or seat within the pool. On the upper surface of the bedrock, directly adjacent to this area of deepening where three small, rock-cut sockets separated by a distance of 1.54m. Although somewhat eroded each socket appeared to have been rectangular in shape and measured c0.09m by 0.10m in size. Each socket had been filled by a greyish-white metal, which had the appearance of melted and re-hardened lead, contained within this greyish-white substance were the remnants of square-shafted iron objects. Each of these iron objects measured approximately 15mm by 60mm. It is possible that these sockets represented the remains of an iron stepladder to enable safe access to the pool.

*Fig 9: Pool 2 (centre ground), view to the south*

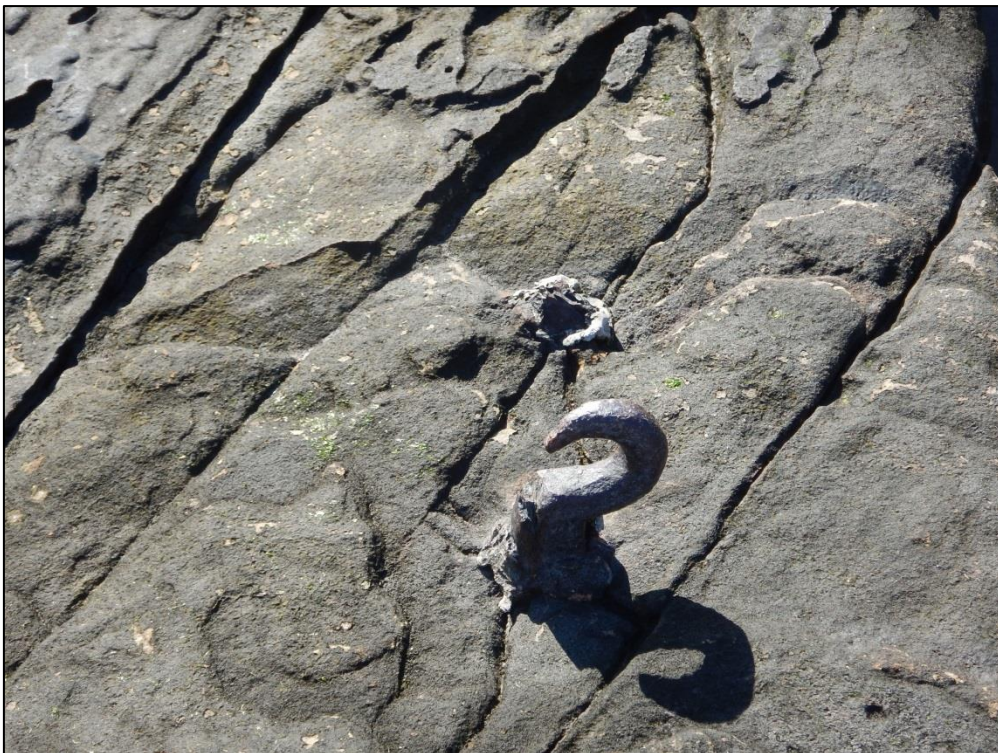
The bedrock to the west of Pool 2 appeared to have been reduced in height by approximately 0.05m to create a flat, though still sloped, platform that measured approximately 5.5m by 6m. Cut into this platform were seven square sockets (see Fig 12) arranged in pairs, to form a triangle. A short distance to the east of this arrangement was a circular socket (see Fig 11), positioned so it was on the centre line of the triangle of square sockets. Each of the square-cut postholes had rounded corners and measured 0.07m by 0.09m and had depth of 0.07m. Arranged around the perimeter of the platform were 29 square-hafted iron hooks (see Fig 10). These hooks measured 0.07m in height with a head that measured 0.04m in width, the haft of each hook measured 0.03m by 0.03m. The hooks had been sunk into small, square cut sockets and secured in place with a greyish-white metal. It is thought that these sockets and hooks secured a tent or canopy over the platform to provide the bathers with some protection from the elements.

*Fig 10: An iron hook forming part of the portable shelter*

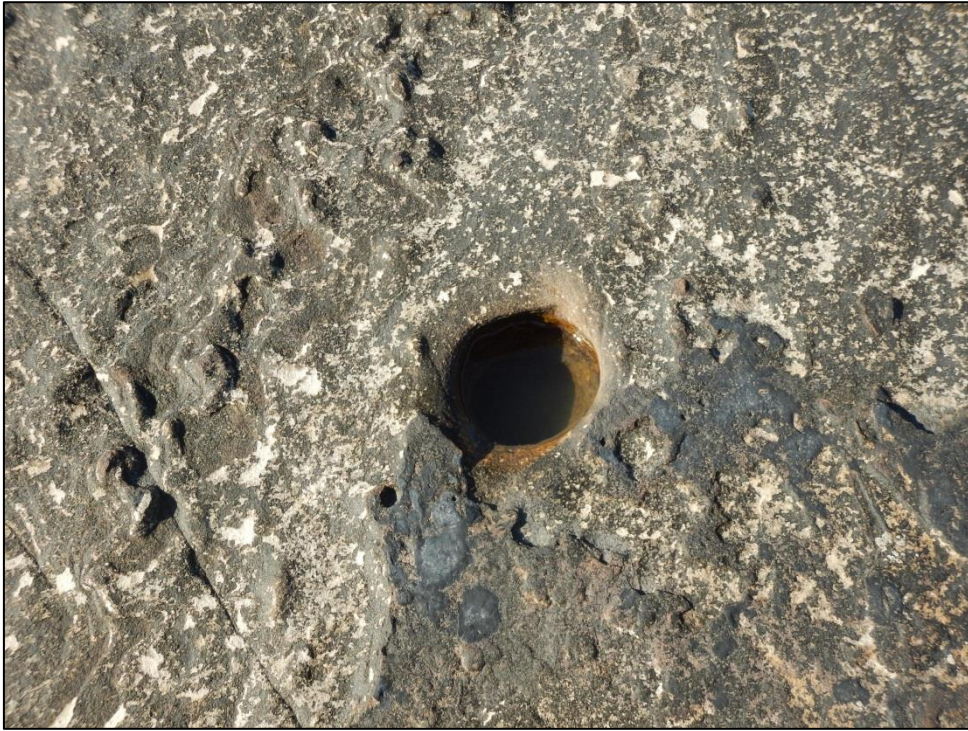
*Fig 11: Circular rock-cut posthole, forming part of the portable shelter*

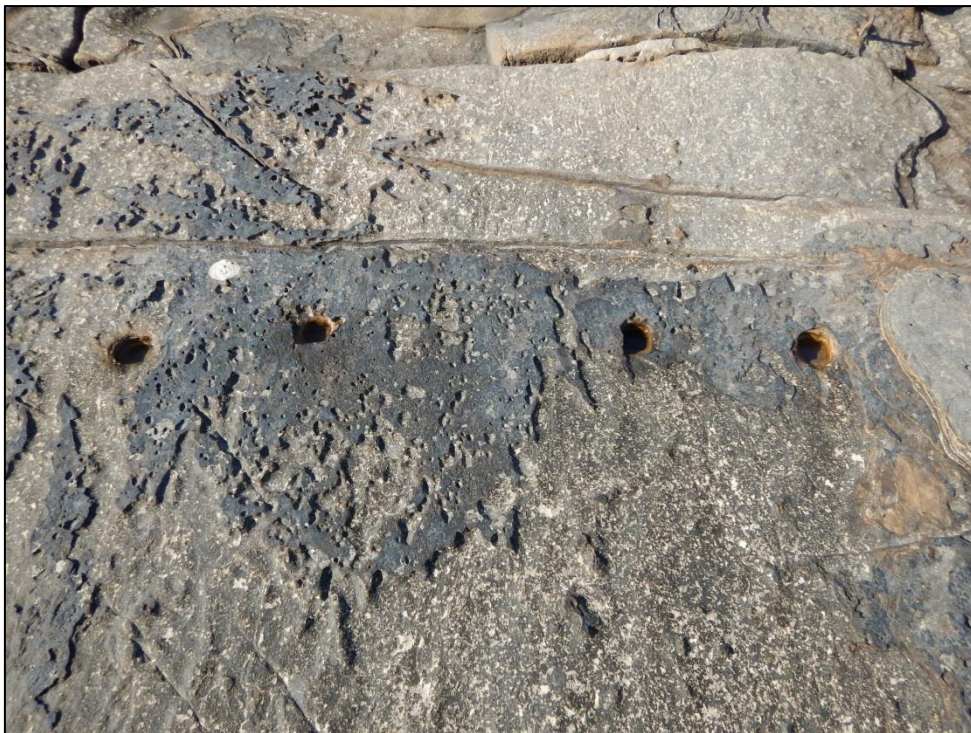
*Fig 12: Four of the square, rock-cut postholes, forming part of the portable shelter*

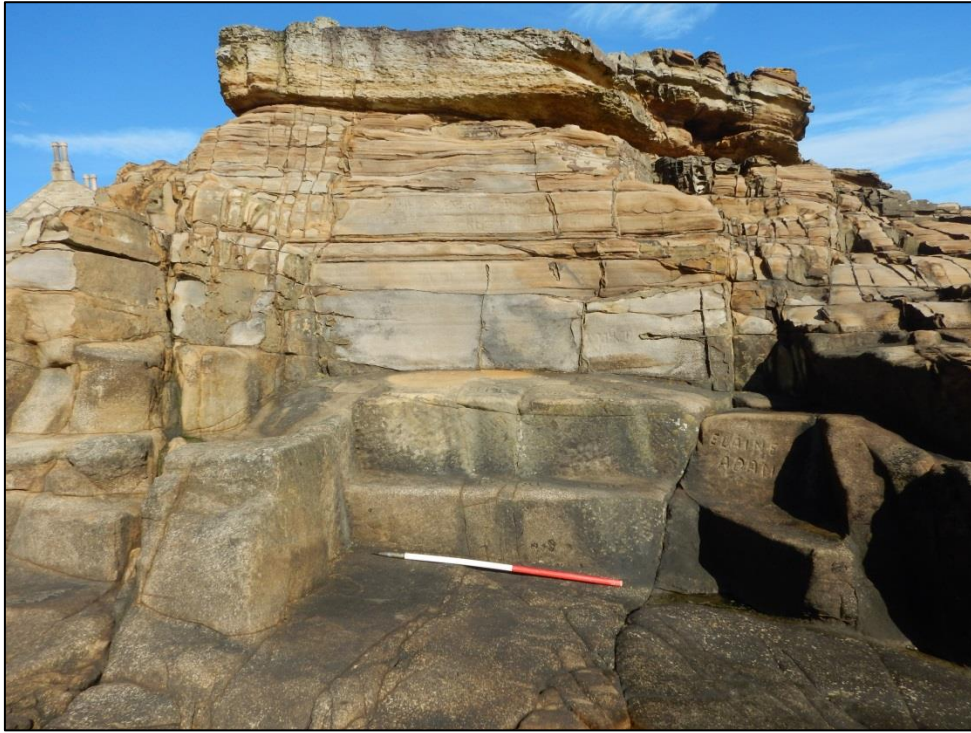
A short distance to the north of the pool a sandstone bluff reached a height of approximately 4.5m above the platform and the pool. Cut into the bluff, approximately 1m above the height of the pool was a short bench (see Fig 13). The bench's set measured 1.60m in length and 0.37m in depth and had a seat height of 0.30m. The bench had a well-faced backrest which measures 1.60m in length and 0.40m in height. In front of the bench the bluff had been levelled to create a small platform that measured 1.36m by 1.78m.

*Fig 13: The rock-cut bench, view to the south*

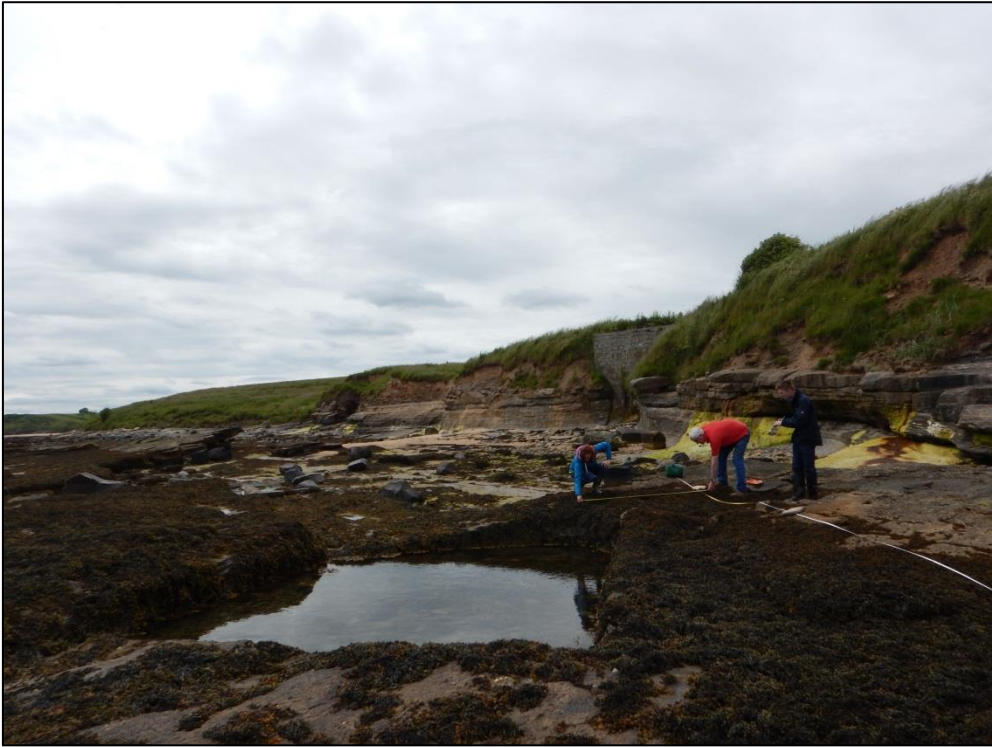
*Fig 15: Citizen volunteers and staff recording Pool 3*

The training event conducted on the 5<sup>th</sup> and 6<sup>th</sup> July was attended by two adult volunteers, neither of whom were local to the site. The training event conducted on the 19<sup>th</sup> and 20<sup>th</sup> July was attended by a single adult volunteer and two under-16 year old volunteers, all of whom were local to this area of Northumberland. (See Figs 15 and 16.)
