Brownsea Island coastal archaeology Poole Harbour Dorset

NGR: SZ 01984 87989 CITiZAN region: South West

Report on a CITiZAN site survey

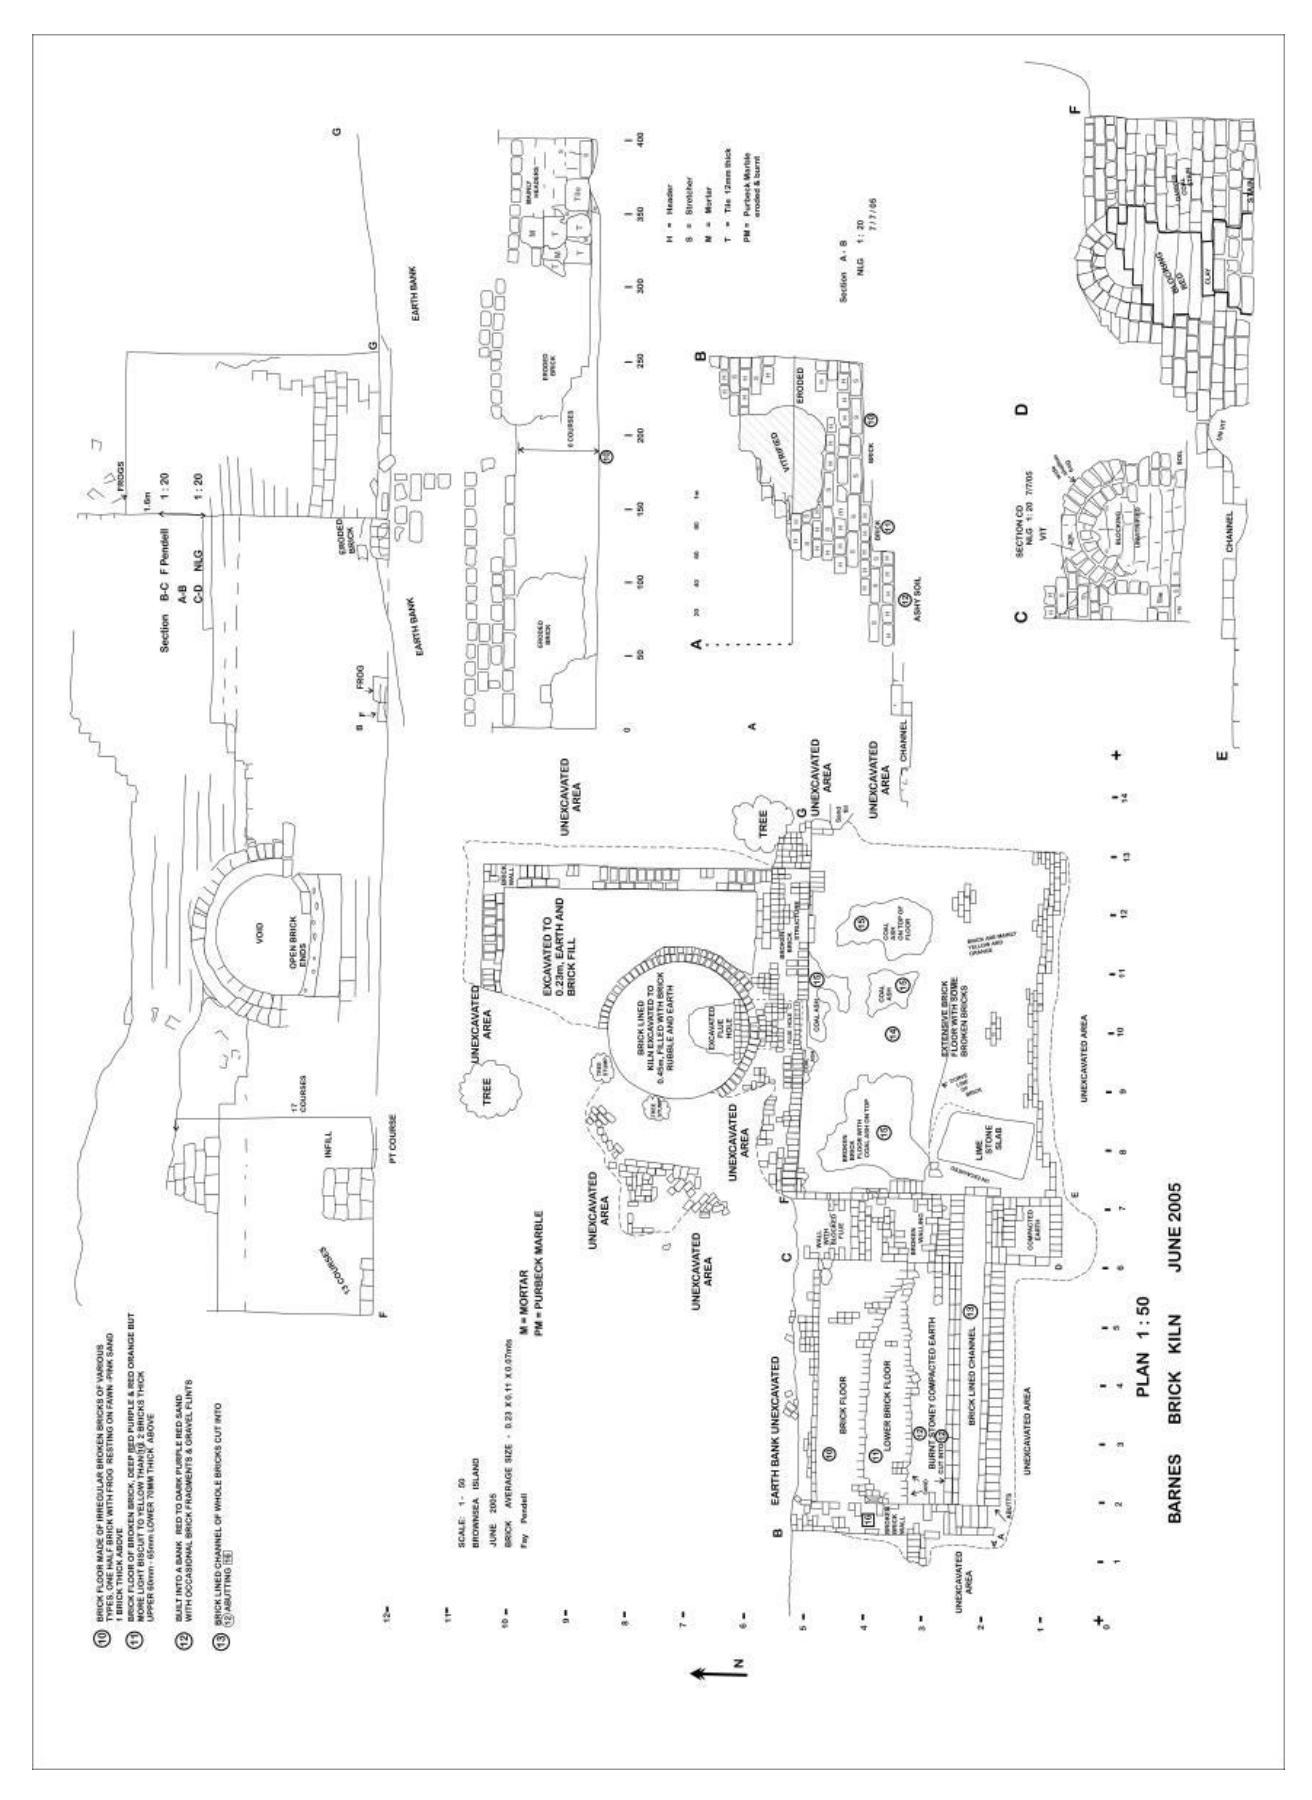
Figure 20: 2005 site plan of Barnes Brick Kiln (Feature 1). Drawn by Martin Papworth (National Trust) digitised by CITiZAN.

In 1988 the kiln was recorded as being 14m long with 4m width exposed on the beach. By 1992 this was 5m. Wooden piles directly to the south were also noted and thought to be the remains of a jetty (Papworth 1992). Clearance by the National Trust in 2005 showed the remains of three rooms, two to the south which survive at floor level and one to the north which was partially covered by an earth bank (**Error! Reference source not found.**). The southerly rooms were thought to be for storage, with the westerly of the two having been converted from an earlier kiln (a blocked flue was recorded here). The northerly room contained a brick lined firing chamber, and contained evidence that lime was fired in the kilns as well as brick (Papworth, 2005). The area surveyed in 2005 covered 14m east west and 10m north south. The jetty was also noted as being 8m wide and 30m long in plan.

CITiZAN first recorded the site in 2015. During the ten years since the last survey the sea defences had been removed and the site had deteriorated markedly. Due to the complexity of the site and the time constraints of tides and site conditions it was decided to record the kiln using photogrammetry.

Initial comparisons between the 1992 and 2005 plans can be seen in Figure 21. In 1992 the earth bank was several meters further seawards and only elements of the two southerly rooms were exposed. By 2005 the earth bank had eroded by up to five metres exposing the firing chamber. Comparing the 2005 site plan to the 2015 model shows that by 2015 the southerly rooms have been completely destroyed (Figure 22). All that remained was the north-east room which contained the brick lined kiln. The whole area to the west of this room was covered in an earth bank in 2005. This had eroded by at least 4m so any remains which were covered by that bank have since been lost. Timber posts in the intertidal zone were still visible which were probably the remains of the jetty. By 2016 the brick lined kiln in the north-east room had partially collapsed (Error! Reference source not found.); this may be due to the vegetation growth above the structure as opposed to damage from the sea.
