# A large mid- Saxon timber structure in the intertidal zone Sea View, Mersea Island, Essex Coastal and Intertidal Zone Archaeological Network Report September 2022

Mersea Island
Discovery Programme
CITIZAN

# A large mid- Saxon timber structure in the intertidal zone Sea View, Mersea Island, Essex, TM 02631 12256 Coastal and Intertidal Zone Archaeological Network (CITiZAN) Report

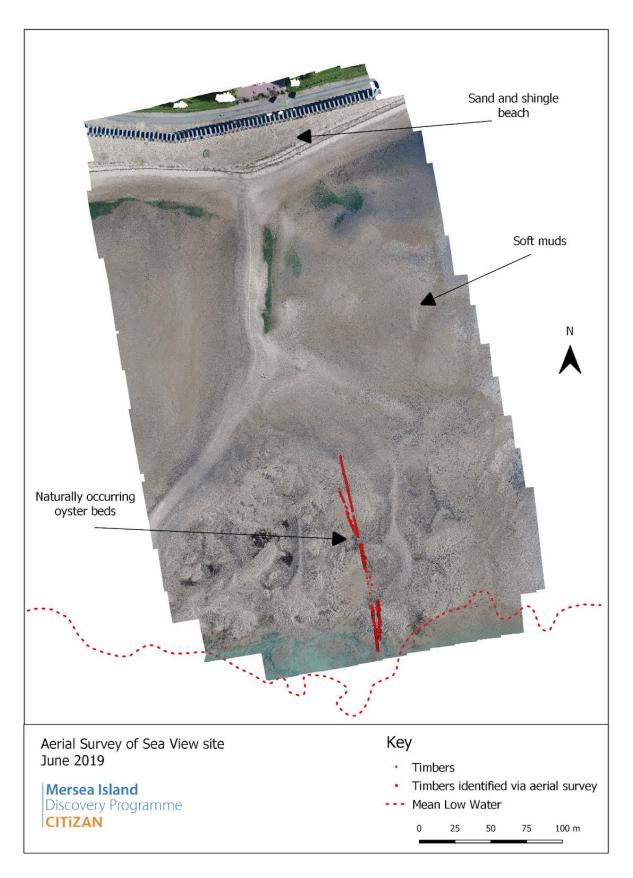
Figure 2: Aerial survey of Sea View Site, June 2019

CITIZAN were alerted to the Sea View site by volunteer James Pullen in the late summer of 2019. He described groups of linear timbers features perpendicular to the present shoreline with a complex arrangement of smaller stakes and uprights towards the low water line. He went on to produce an aerial survey (fig.2) of the area and proposed CITIZAN visit the site for an initial walkover survey to confirm that the site was not modern and of archaeological interest. This was undertaken by CITIZAN Archaeologist Oliver Hutchinson in October 2019 and a sample of uprights were surveyed to record presence/absence of bark, tool marks, dimensions etc. Non-invasive cleaning back of oyster shells and loose muds was conducted to examine the makeup of the foreshore. Samples of an exposed wattle panel or collapsed wattle fence were taken on the basis that the remains appeared fragile and at risk of imminent loss. The panel may provide a Relative Sea Level Indicator point when dated and if confirmed to be in situ.
